# **ENFIELD ARCHAEOLOGICAL SOCIETY ARCHIVE REPORT**

## **EXCAVATIONS AND EVALUATIONS AT ELSYNG PALACE, FORTY HALL, ENFIELD, JANUARY TO JULY 2026**

**(SITE CODE FXY26)**

**MARTIN J. DEARNE**

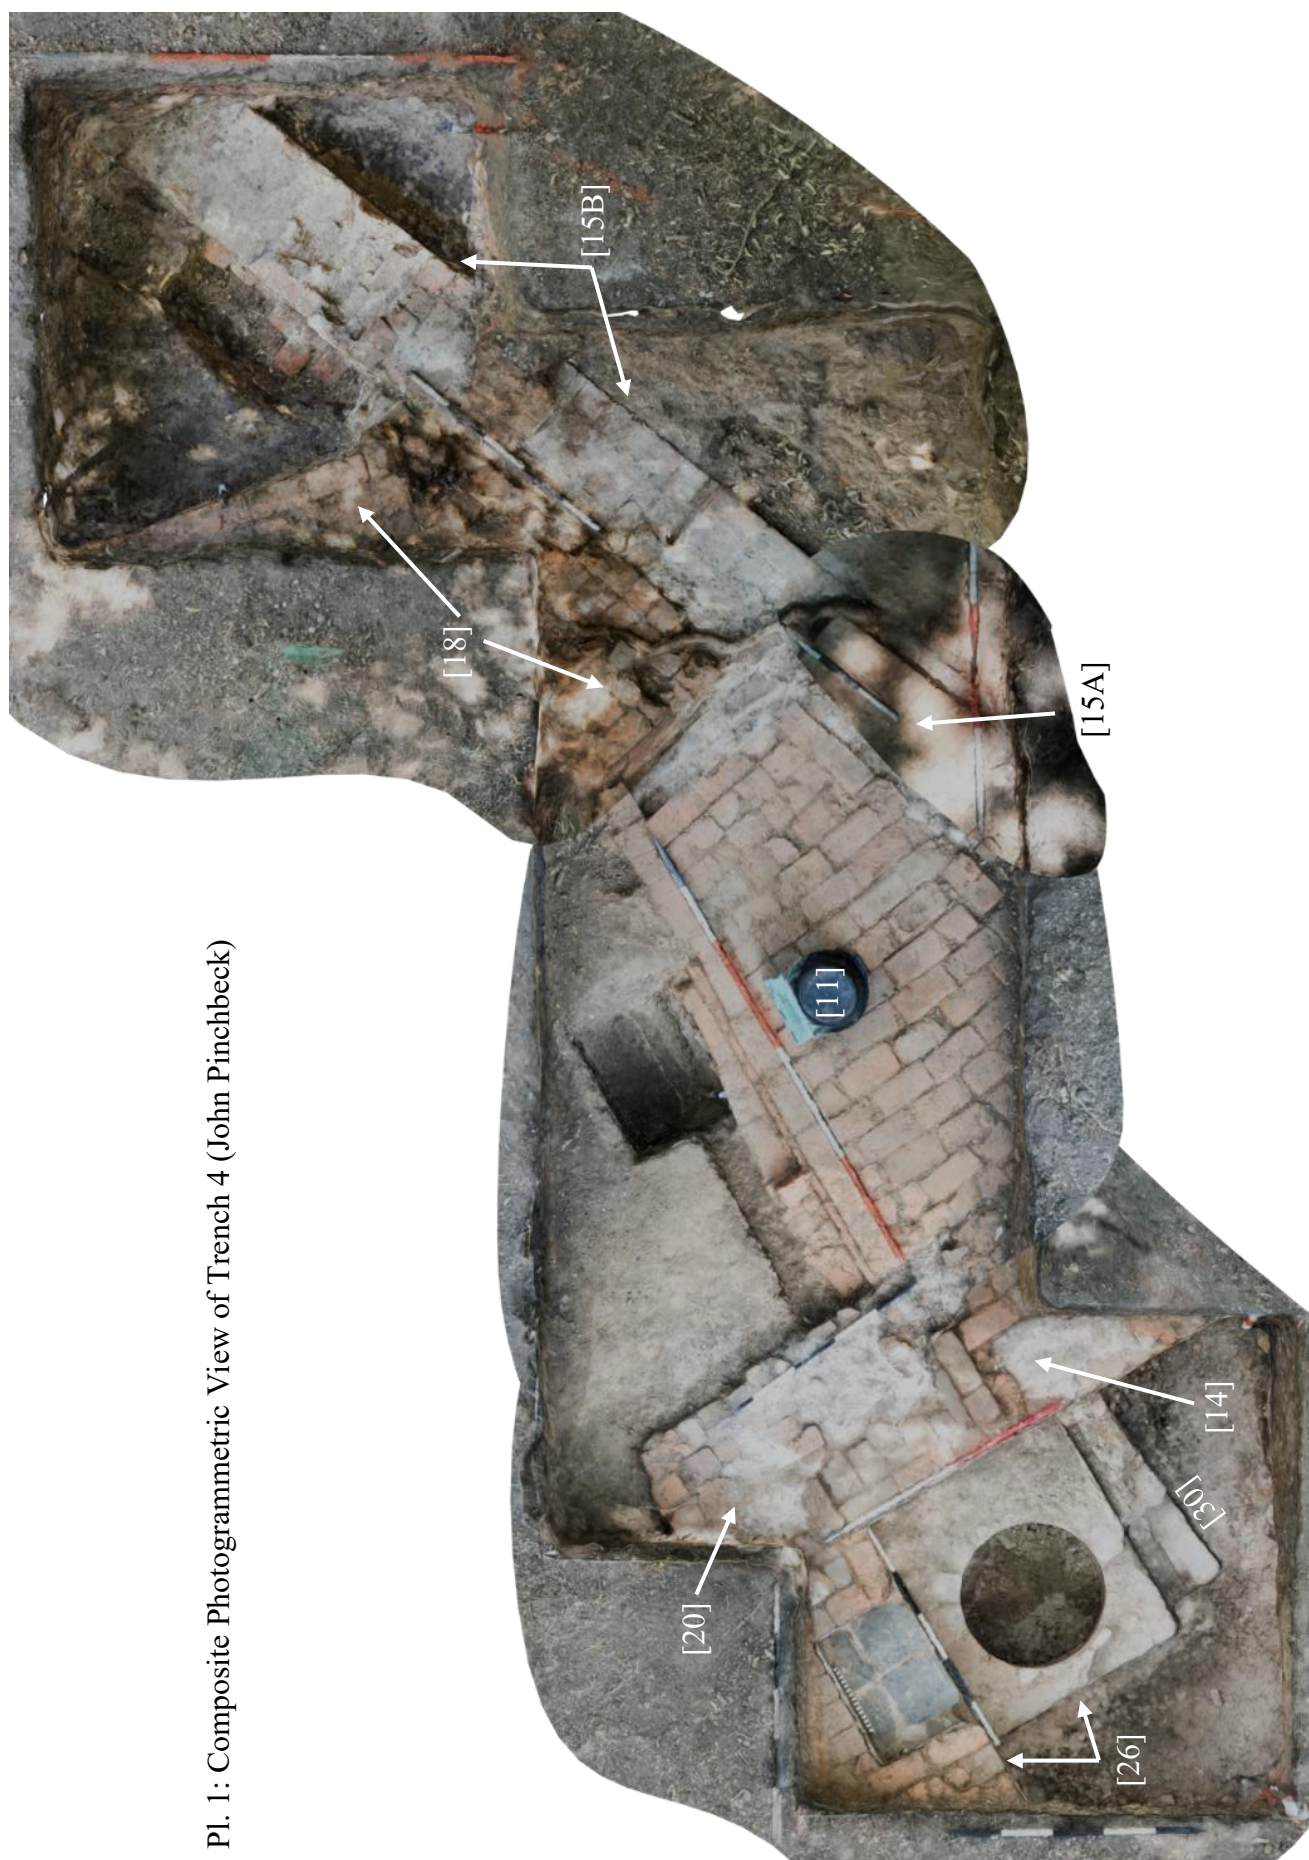
Pl. 1: Composite Photogrammetric View of Trench 4 (John Pinchbeck)

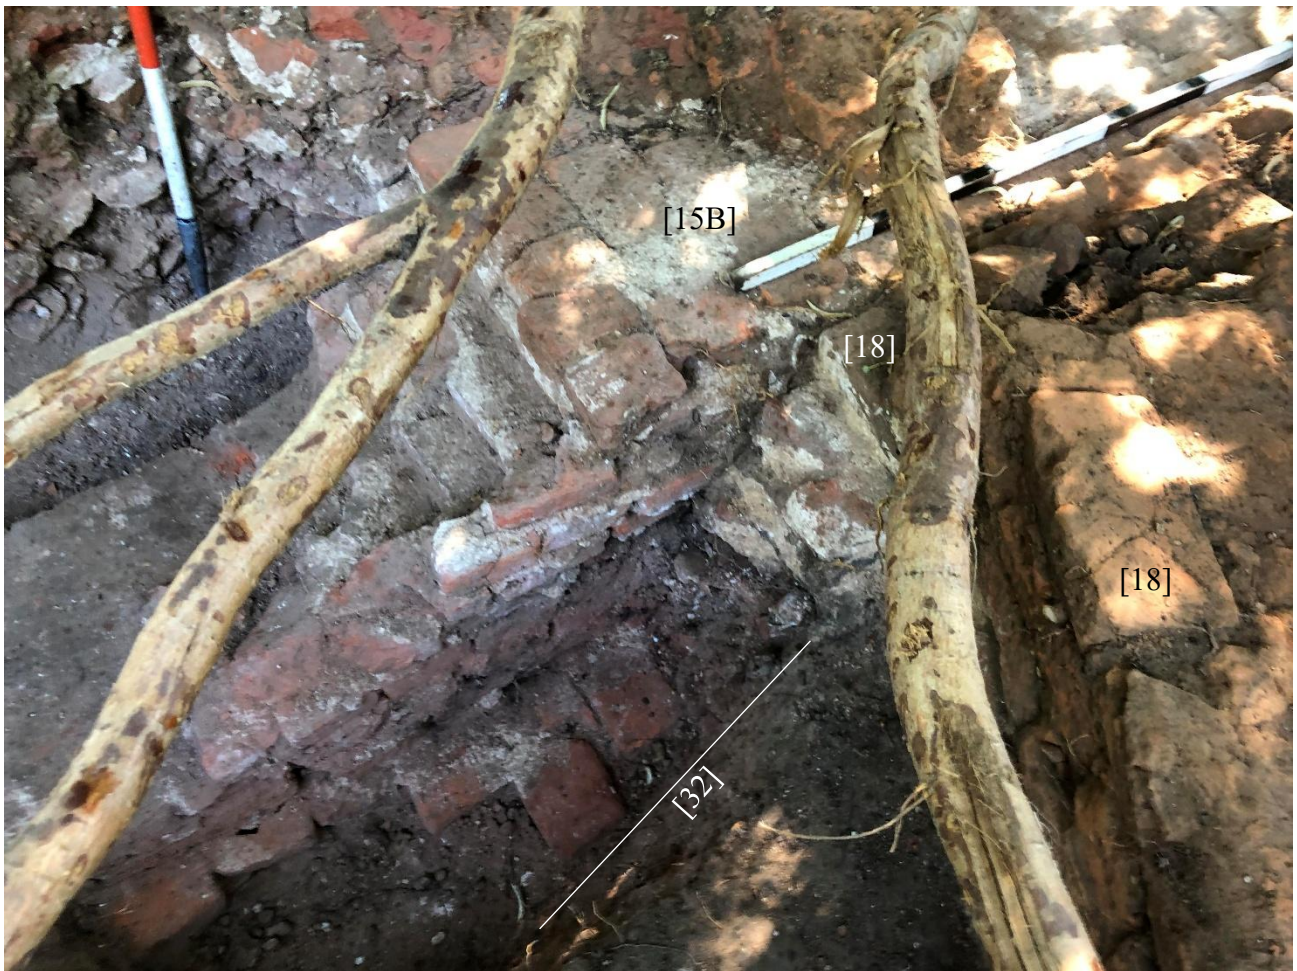
Pl 2: Wall [15B] and Construction Trench [32] with Feature [18] to the Right, Looking East  
(photo John Pinchbeck)

- The possible c. 0.30 m wide channel or gap at the north west end of [11] (coincident with the western end of [15A]) separated it from [18] which had at least one offset where it formed the other side of this ?channel/gap. However, the ?channel/gap was obscured by [19], a mass of part bricks and complete peg tiles set angularly on their edges (Pl. 13) which had been secured with hard white mortar and only some of the peg tiles were removed (as the feature was deemed to be structural). Beyond this possible channel or gap [18], which was much more demolition damaged in Phase 5a making analysis of its structure problematic, appeared to extend the line of [11] against the south side of [15B] (whether here it had been partly demolished or not) for up to another 1.90 m. [18] though had a surface at least one brick course higher than [11] and had a north west butt end (built over earlier loose fill [31] which it had truncated) which had either been left protruding as rough brickwork or had been demolished before Phase 5a (Pl. 2).<sup>5</sup>

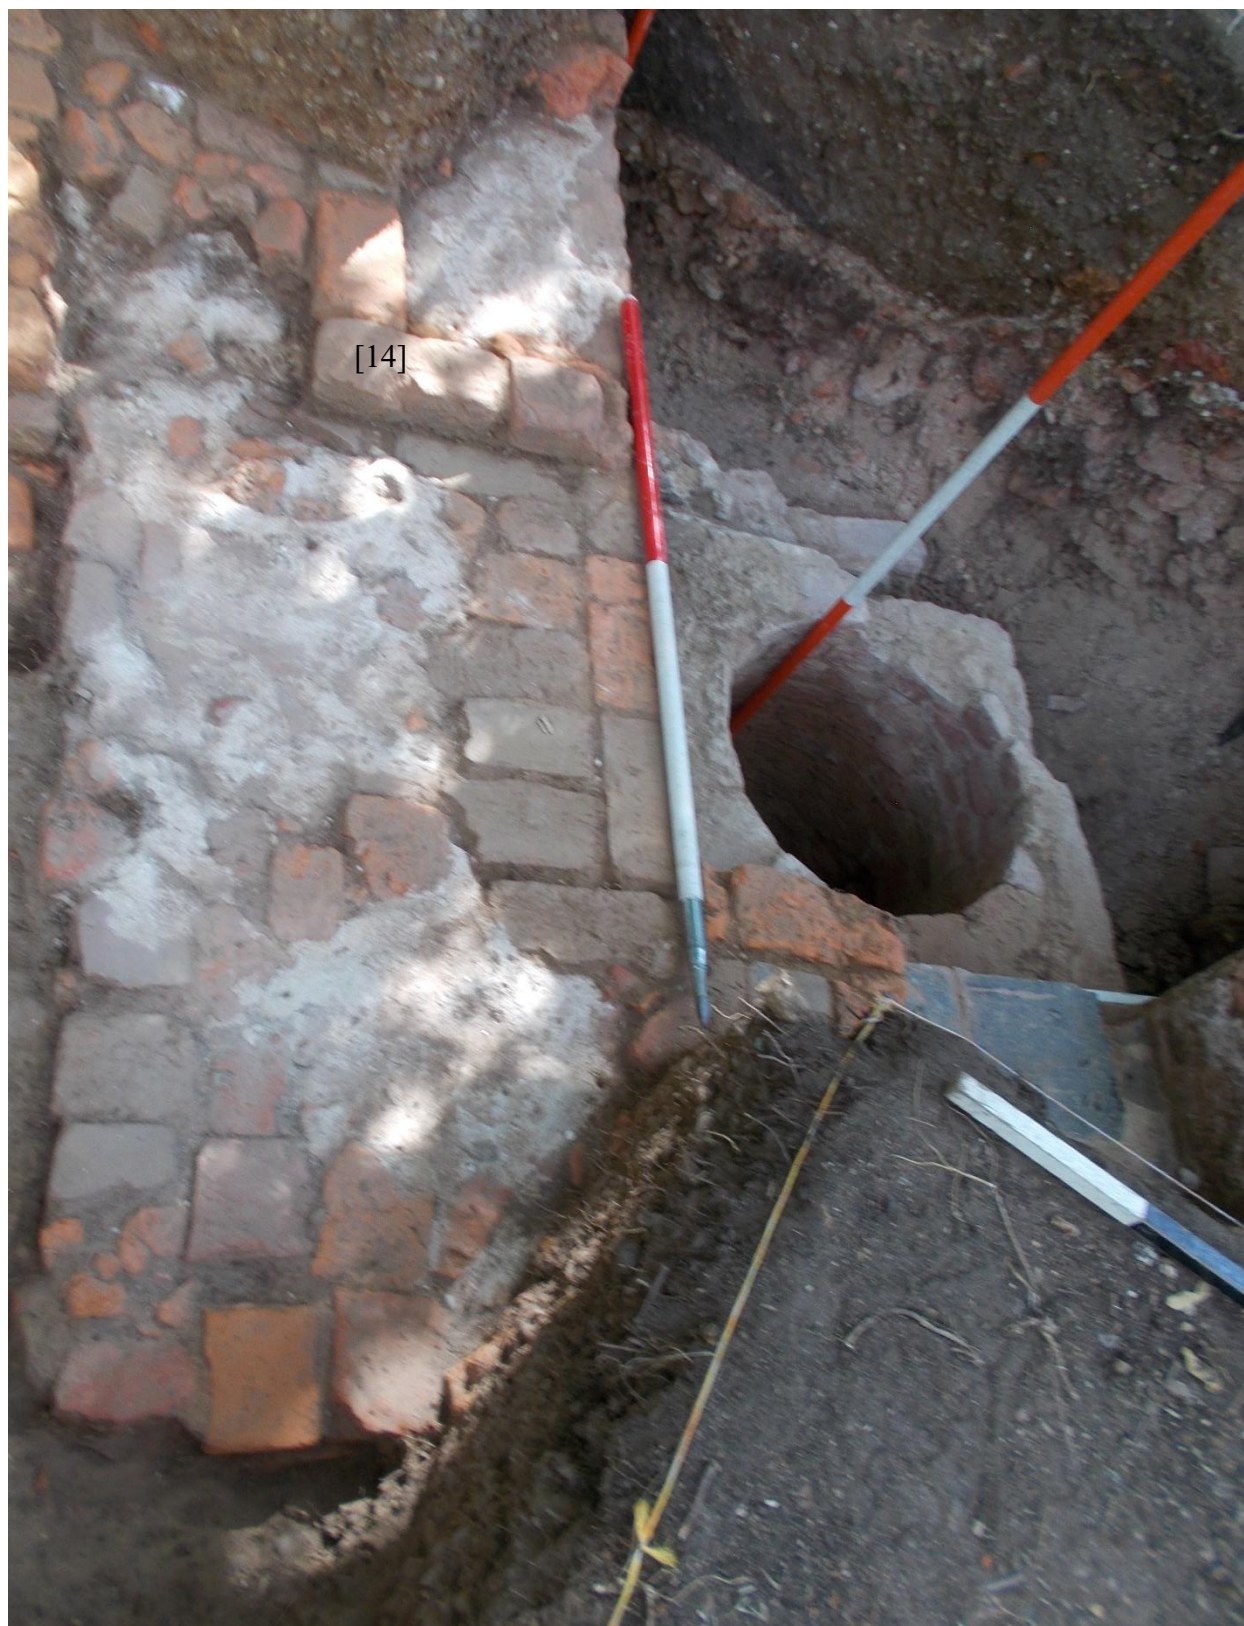
Pl. 3: Wall [20] ([26]/[30] to its Right) with Wall [14] Partially Overlaying and Elements of [11] Removed to the Left of [14], Looking East (photo MJD)

- Further south, wall [20] (Pl. 3) survived to over 1.32 m above the limit of excavation, was well built with hard white mortar in English bond, and had been white mortar rendered on its south face, but not (though little of it was seen) on its north which had probably been left relatively poorly finished at the level at which it was seen. Its western end was within Trench 4 and here it narrowed a little from its otherwise width of c. 0.75 m, while its demolished or damaged eastern end had been recorded in FXX25 Trench 5 as FXX25 [20] (though in part what was recorded then can now be seen to include a later rebuild described below). Thus its overall length was at least 3.20 m.

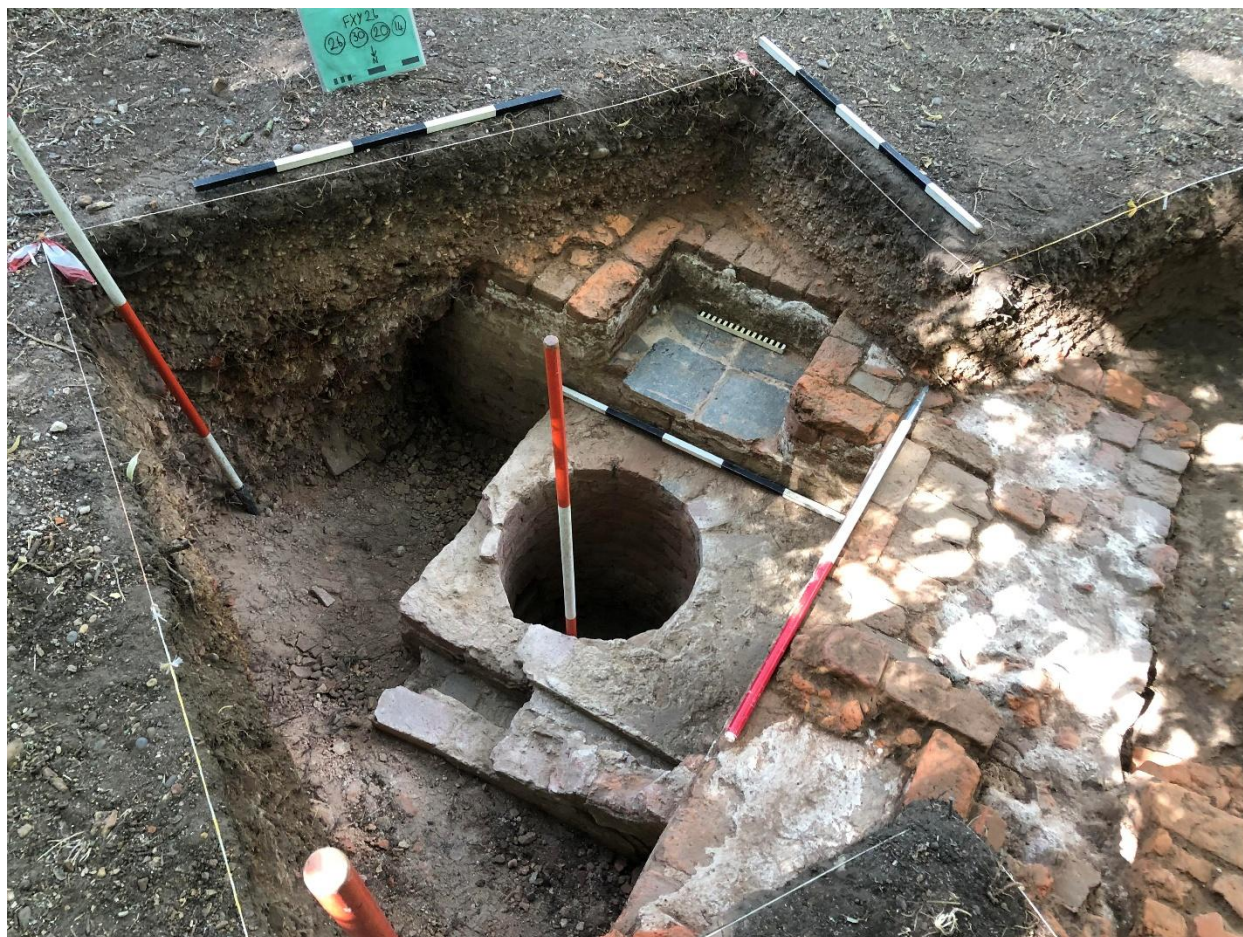
Pl. 4: Features [26] and [30] with Wall [20] to Right Overlain by Wall [14], Looking West  
(photo John Pinchbeck)

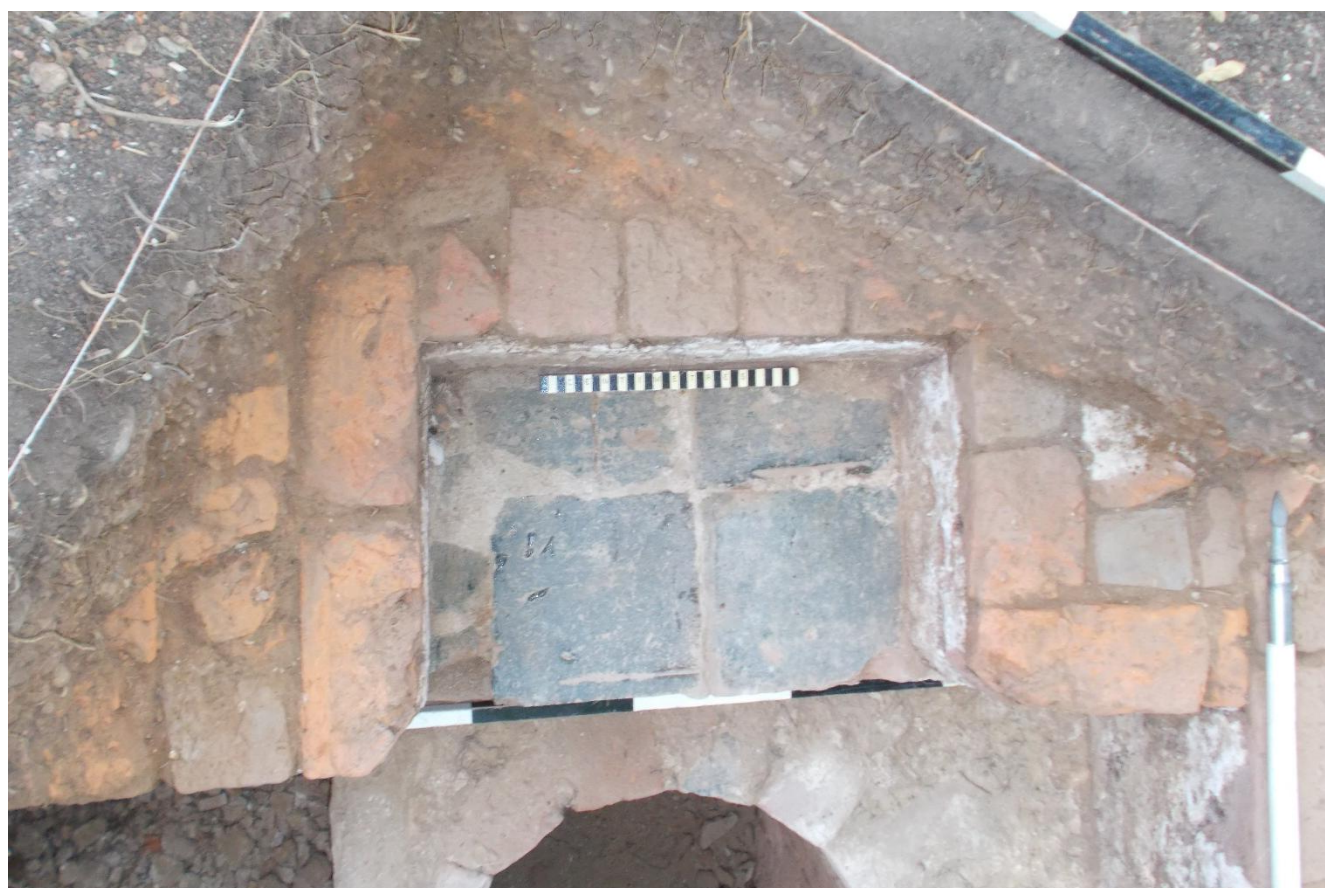
Pl. 5: Detail of the Rebate in [26] (photo MJD)

- The rebate may have formed either a waterproofed adjunct to the well (e.g. for standing a bucket in) or a step giving access to the well, which was set to its east and encased in brickwork with an upper hard white mortar rendered surface, 0.115 m lower than the base of the rebate, and a more roughly rendered south face. The well (Pl. 6) had an internal diameter of 0.58 m and was cleared to a depth of 0.80 m, showing that it was built of over 12 courses of neatly lain headers, and it was probed to a depth of 2.02 m. It showed at least three areas of ?damage/repair, two diagonally opposite (north east and south west) individual bricks appearing to be absent at a depth of 0.70 m and at a depth of 0.50 m on the south a hole might have been repaired by inserting two new bricks, but still leaving a void above them.

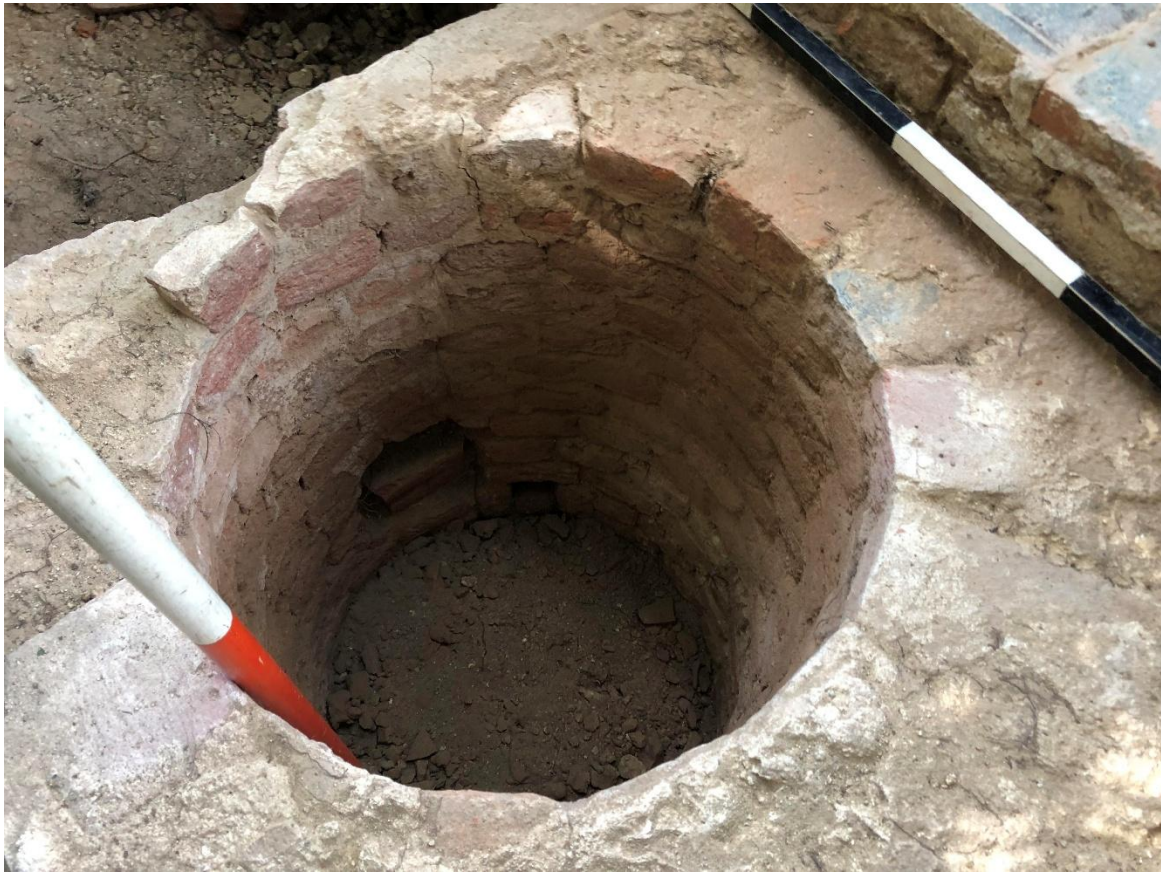
Pl. 6: Detail of Well [26], Looking South (photo John Pinchbeck)

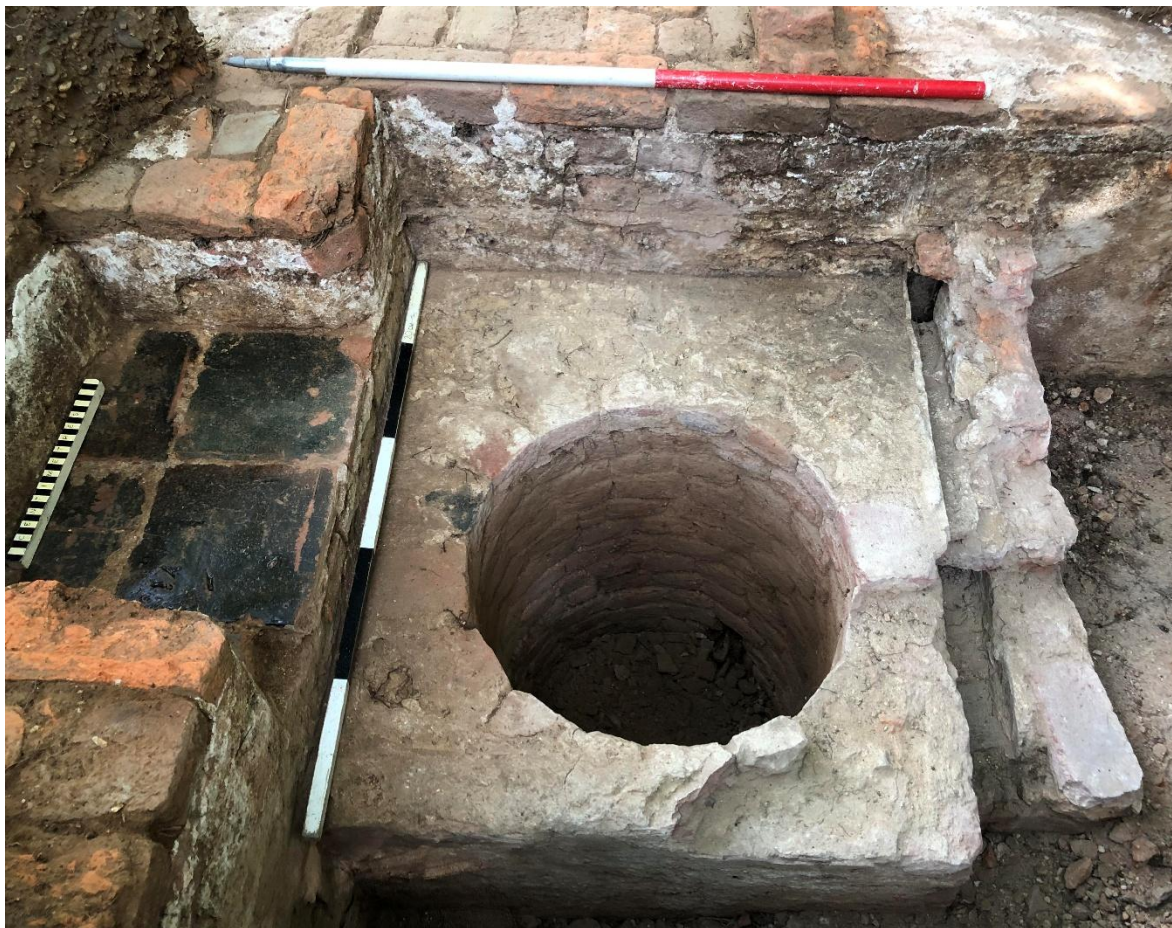
Pl 8: [26] and [30] Looking North (photo John Pinchbeck)

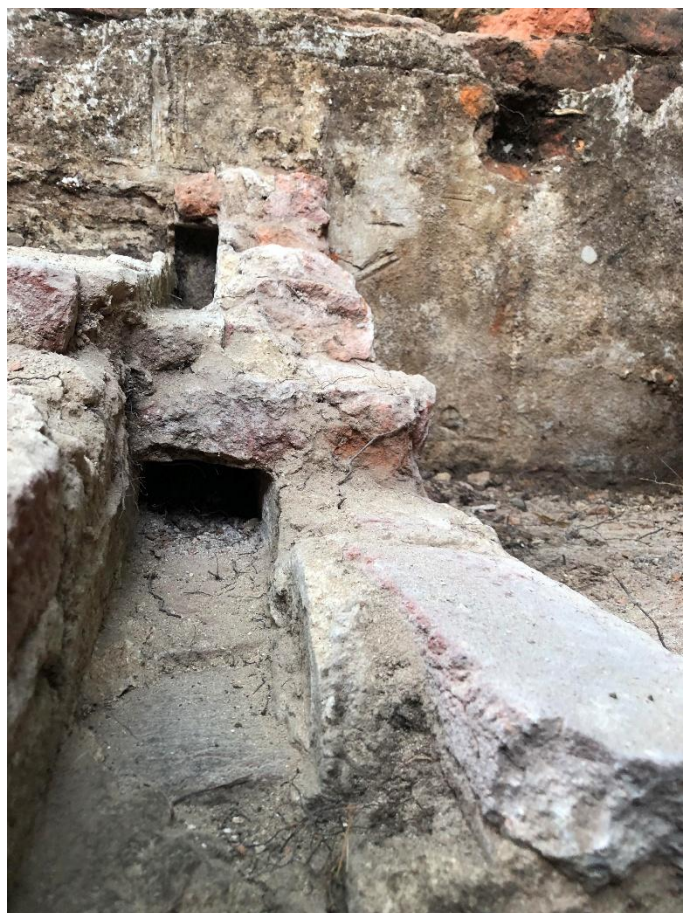
Pl. 9: Detail of Channels in [30] Looking North (photo John Pinchbeck)

- What the function of the channels in the feature ([30]) that was attached to the well was is more problematic. Clearly neither took a very heavy flow of water, but damage to the surface of the brickwork the well was set in and also to [30] itself prevents certainty about where those flows originated. One possibility is that the upper channel was open to the surface of the well setting further south than it was preserved and served as an overflow for spillages resulting from use of the well. The function of the iron fittings in the recess beside this upper channel is though also not immediately obvious. One might speculate that they formed parts of some form of mechanism, maybe using a leather flap and operated from a gap in the (lost) west side of the channel, by which the descending channel could perhaps be opened or closed off, but this can only be speculation.

- The lower channel clearly took a slightly greater flow and maybe it had served something like a small sump that waste water could be poured into, but the damage to [30] makes it impossible to be sure. Without deeper excavation it is also impossible to know if these channels communicated with, for instance, a larger ?drain that perhaps passed through wall [20], but they seem to make little sense unless they did (see further below).

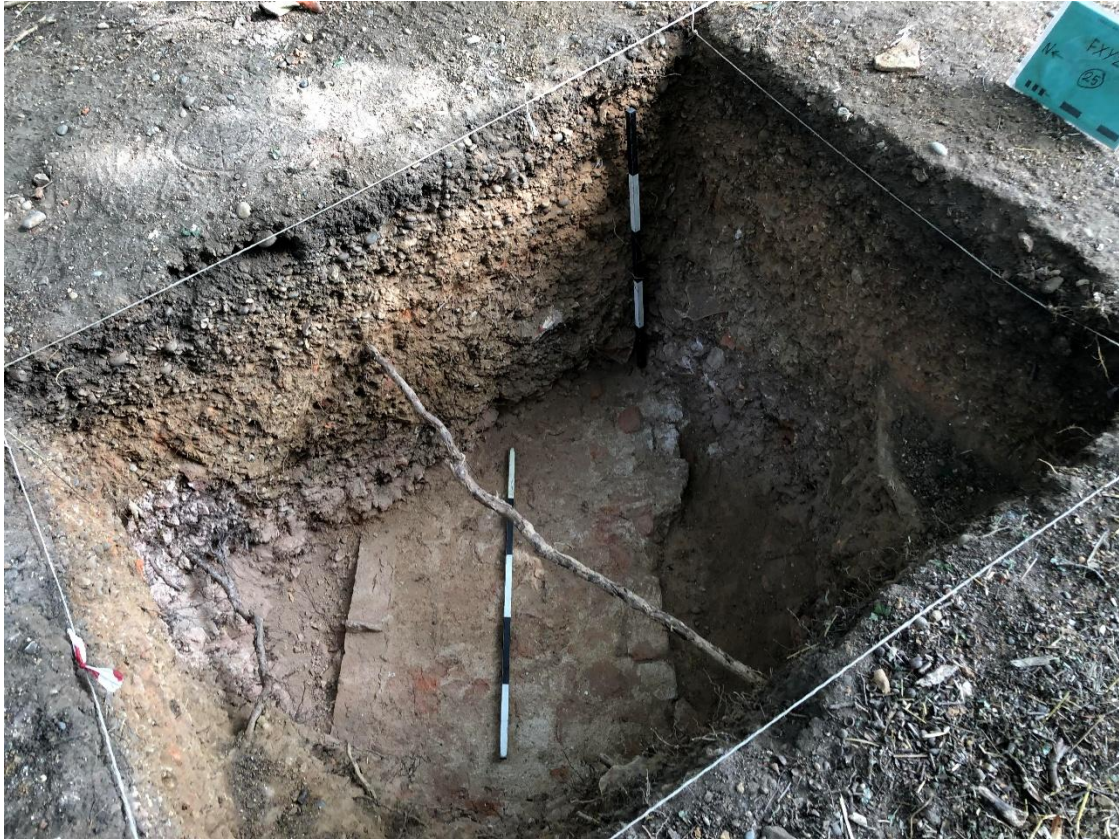
Pl. 10: Wall [25] Looking North (photo John Pinchbeck)

- As in 2025 with FXX25 [19], the depth of the foundations of [25], and their width, suggest that this was a major structural wall supporting a multi storied construction. Whether it was an external wall was not certain and loose Phase 5a demolition rubble ([24]) continued below the limit of excavation to its west, raising the possibility that (as with the area bounded by FXX25 [19] and its return) it delimited a cellar. However, the very small exposure of the area beyond the wall and limit on excavation depth make it impossible to draw any reliable conclusion and it must be quite likely that [25] represented the western limit of the inner gatehouse at this point.

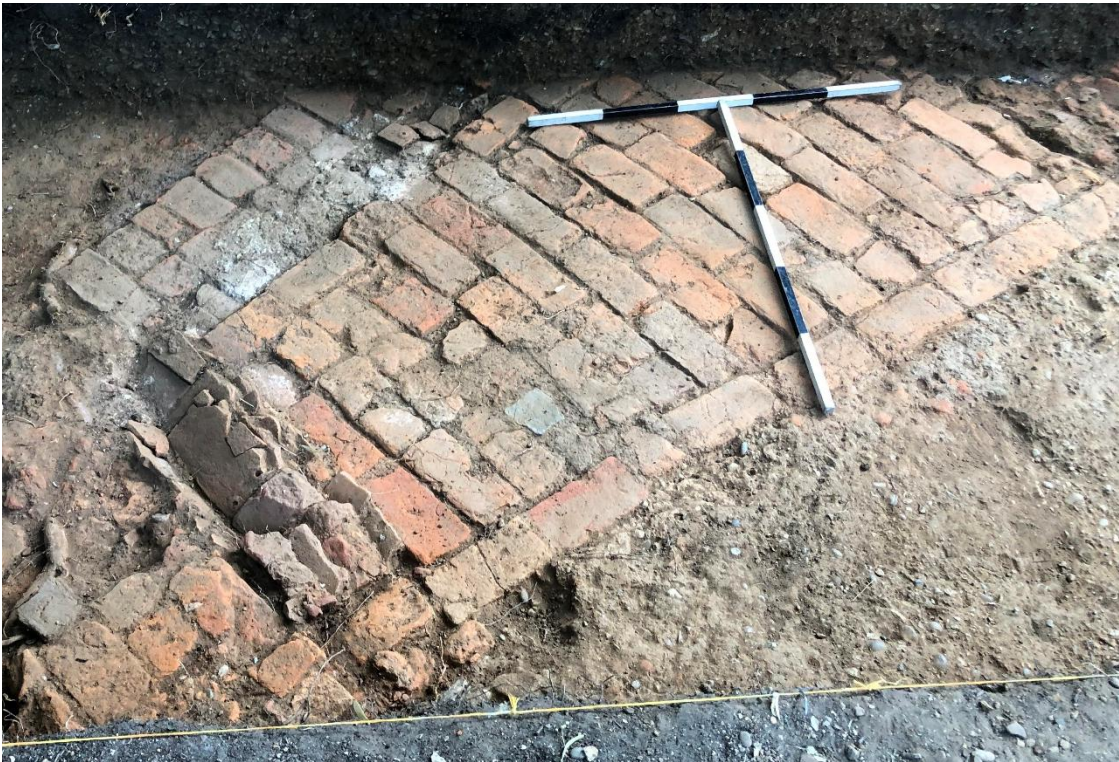
Pl. 11: Feature [11] with [15A] to Top Left and the Channel/Gap Filled by [19] to Left, Looking East (photo John Pinchbeck)

- The absence of any traces of mortar on the bricks forming the upper surface of [11], which also had a slope down to the east, strongly suggested that it had been an exposed surface and potentially a floor. However, limited excavation along its west edge showed that it was far too deeply founded to only be a floor, if it had acted as one at all. Thus, its upper course lay on two more courses of English bonded bricks using off white mortar and forming two (0.05 and 0.07 – 0.15 m wide) poorly aligned offsets, themselves above three very poorly lain courses of headers and at least another 0.19 m depth of mortar raft or mortar faced bricks, so that [11] was set a minimum of 0.57 m into the ground (Pl. 12). Its upper surface used part as well as whole bricks, increasing poorly lain as it ran east, and over the north side of the demolished surface of wall [20] the upper surface of [11] had been extended by mortaring bricks fragments, and further west little more than pieces of brick rubble,<sup>4</sup> over it.

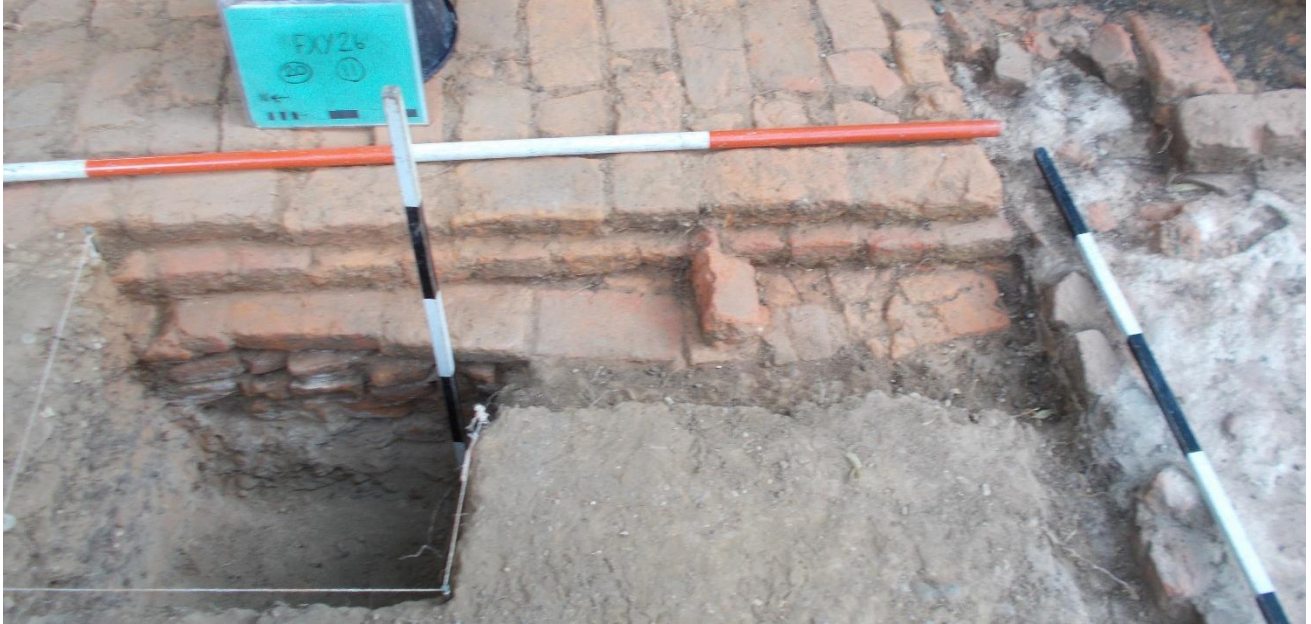
Pl. 12: The foundations of [11] and its Meeting with [20] to the Right, Looking East (photo MJD)

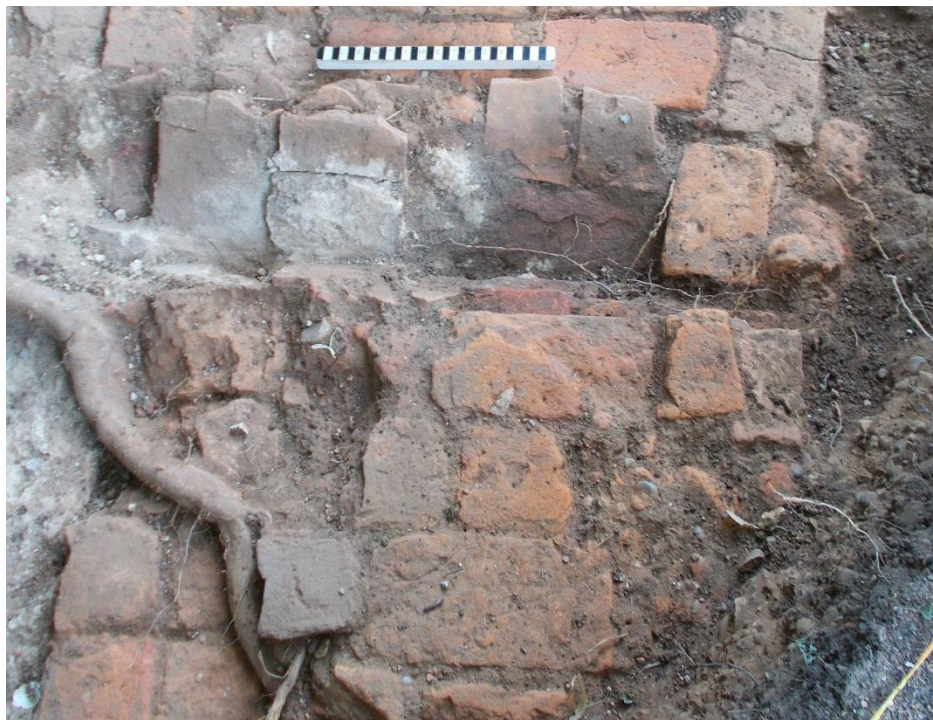
Pl. 13: Detail of [19] Filling the Channel/Gap Between [11] and (at Bottom) [18] After Removal of One Layer of Peg Tiles, Looking South (photo MJD)

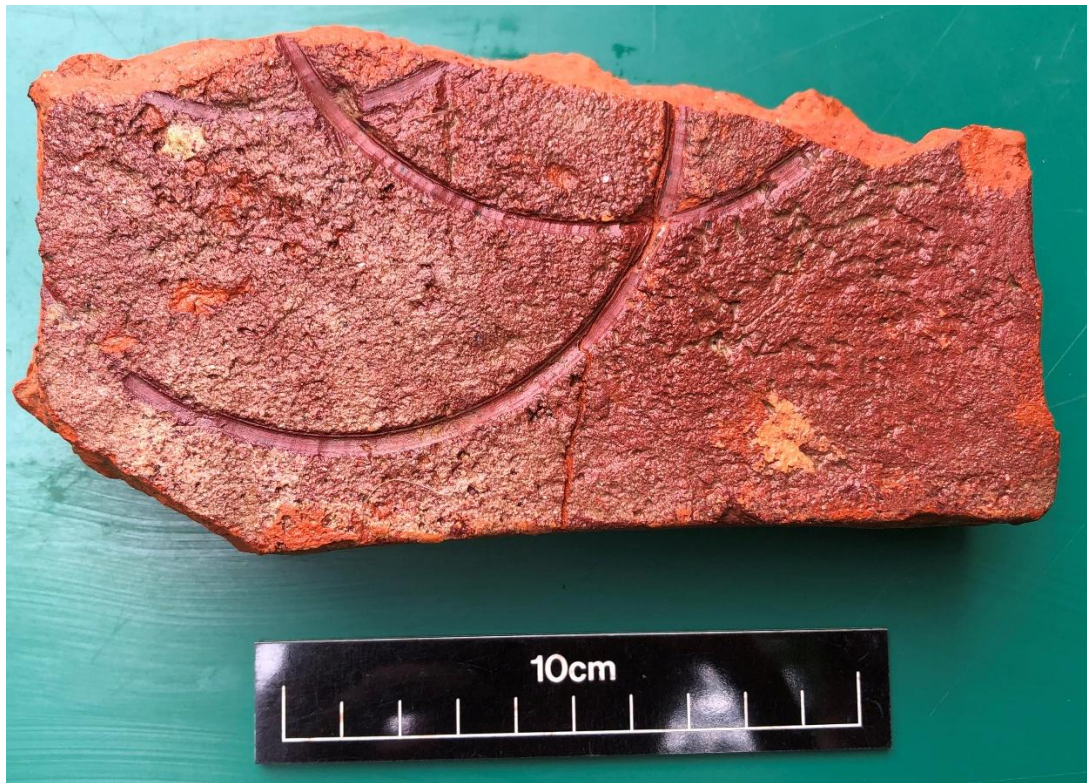
Pl. 14: Markings on Back of a Glazed Floor Tile (photo John Pinchbeck)
