# **Monarchs, Courtiers and Technocrats; Elsyng Palace, Enfield: Place and People**

**The Documentary and Archaeological Evidence for a Fifteenth to  
Seventeenth Century Courtier's House and Tudor and Stuart Royal  
Palace; and for the Lives of its Owners and Households**

## **The 1963 – 6 Excavations: a Description and Re-evaluation**

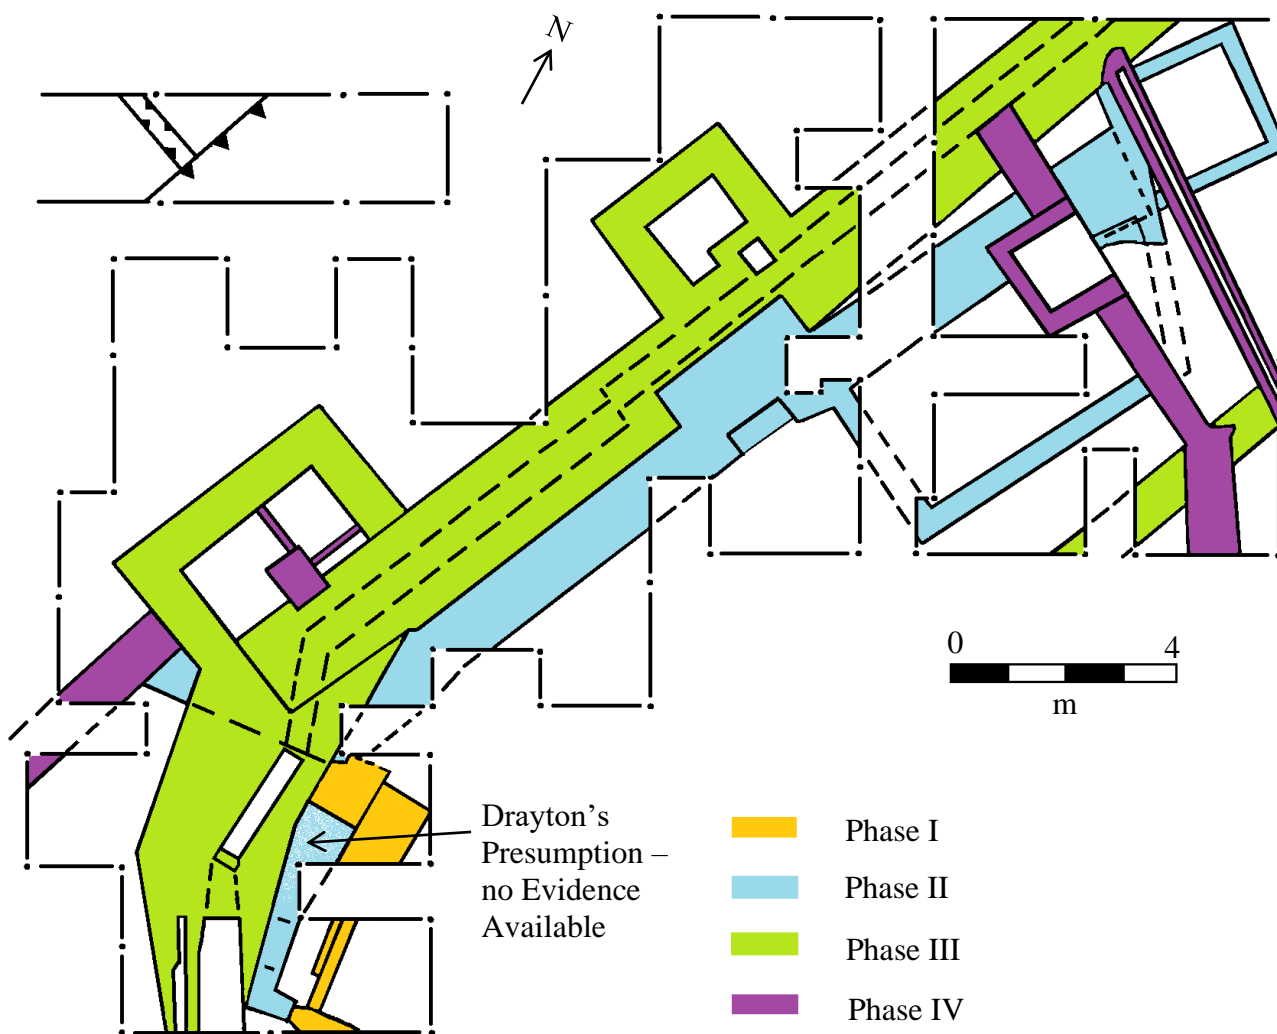
Fig. 2: The Tentative Revised Phasing Discussed Below

Any re-assessment of the site has now to be very cautious given the paucity of the site records so the following structural description/commentary is perforce organised according to the four phase scheme adopted by Drayton as the records will not sustain a *de novo* phase analysis. It does though seem that her Phases II – IV represent genuine successive building phases even if it is argued below that some features were misinterpreted and or assigned to the wrong phase (Fig. 2).

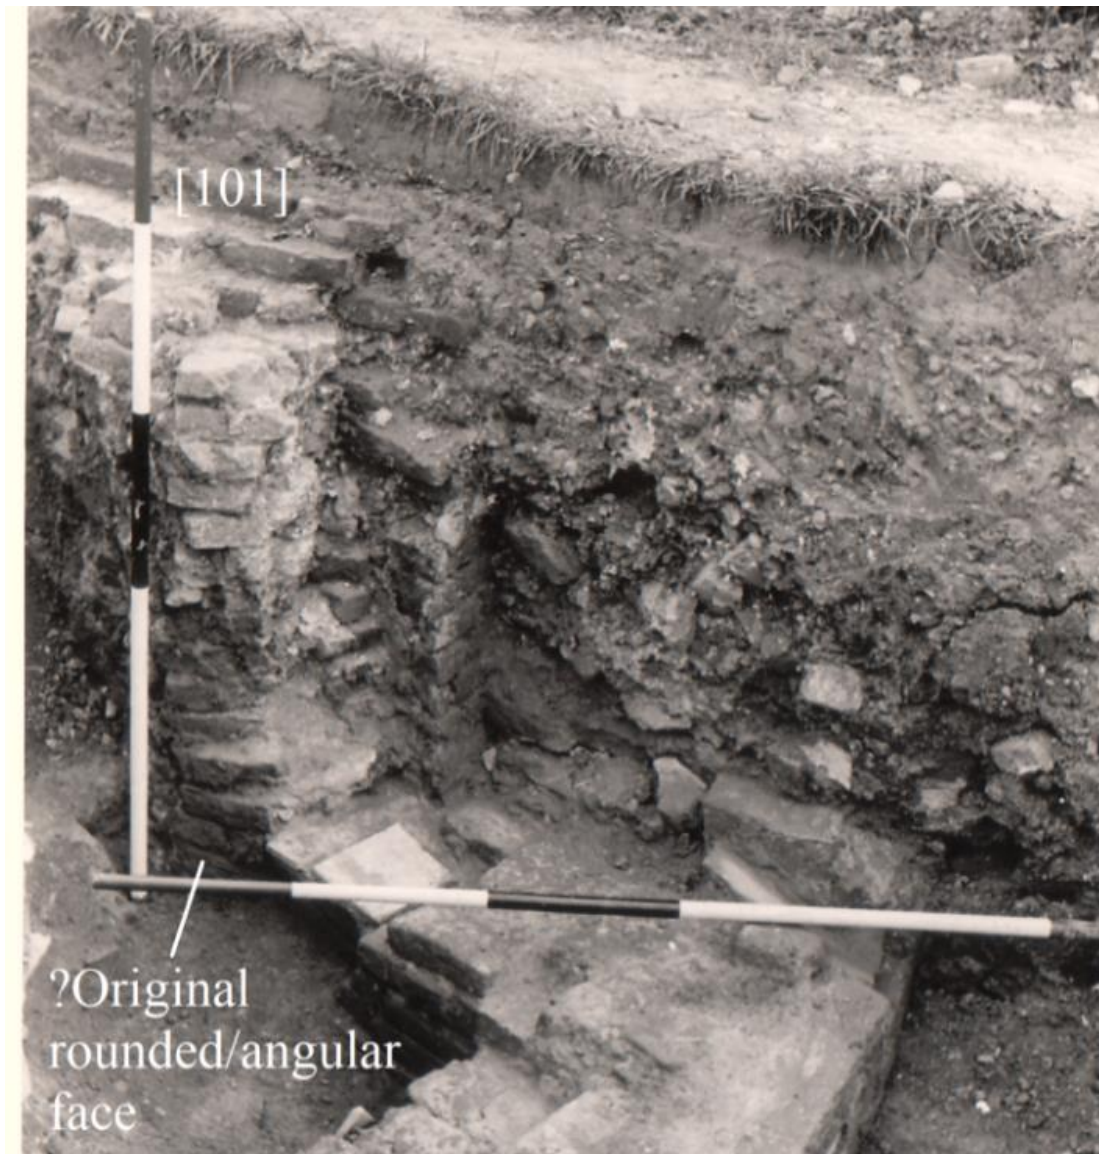
Pl. 2: Tr. F, Wall [101], Looking South

Whether one of Drayton's reasons for equating the walls or not, she noted that 'in every case the early brickwork had been almost completely robbed out, only one or two courses being left'.<sup>9</sup> However, that is patently untrue, besides leaving the question of why a wall like [115] (see Phase II), demolished to a ?similar level to [102], was allocated to Phase II not Phase I. Wall [101], in fact survived to above the level of almost all other structures on the site; built of English bond brickwork, it was only covered by topsoil and survived to at least 18 courses (Pl. 2).

Clearly wall [101] was fairly thick (what plans there are perhaps suggesting over 1.60 m) and had an original face on the north west showing it ran approximately south west to north east like the timbers [105] (Pls 2 and 4). But part of this original face had been cut away when the south end of a new wall, [112], was constructed in Phase II and [101] looks like it had been ?demolished (?again when [112] was built) on the north side. If so, how far north it originally continued – or whether this was just damage to the face of the wall – records are inadequate to decide and all that can be said is that nothing in the site records hints at it continuing significantly further north while photographs perhaps suggest that the north west face only continued as far as a rounded/angled turn still preserved in the lower courses of the wall (Pl. 2). One might then wonder if it was substantially complete except for damage to its north face; but records are just inadequate to decide.

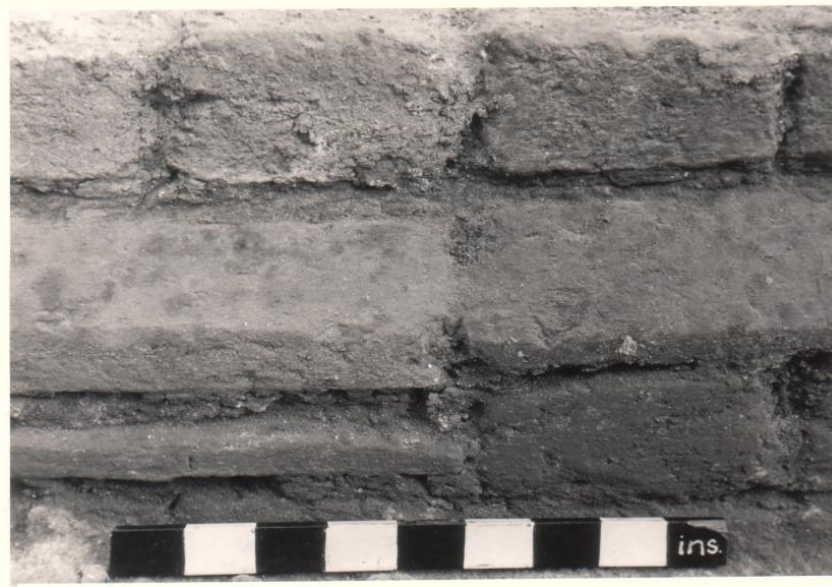
Pl. 6: Detail of Plinth in Wall [106]

It comprised at least seven and presumably at least several more courses of English bond brickwork below the plinth, in some cases with a (?levelling) peg tile course inserted directly below the plinth. Its principal surviving feature was the fireplace and chimney base, [110], the hearth built into the south east side of a 2.44 m wide north western thickening and 0.61 m deep projection of the main wall (Pl. 7). The hearth itself (Pl. 8), 1.17 m wide and 0.51 m, deep, was floored with two courses of header lain bricks and its superstructure survived to 16 courses of mostly English bond brickwork. Its north east internal face was vertical, but the south west internal face incorporated five stepped stretcher courses (beginning with the fourth above the floor) to broaden the chimney flue (perhaps with one small step further up).

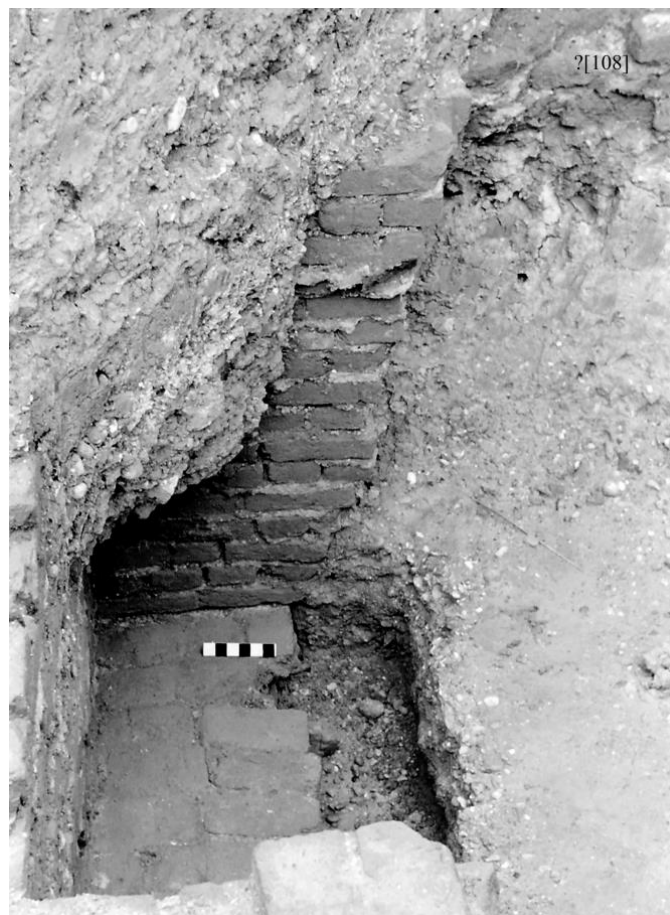
Pl. 9: Tr. N, Fireplace [110] (?with Wall [108] Top Right), Looking North East

At the north east end of the fireplace, wall [106] turned slightly more eastwards and appears to have projected to the south east as it rose up, just north east of the fireplace (Pl. 9). An annotated sketch plan suggests that in Trench M it was 0.89 m wide (so essentially the same width as further south west) and photographs again show the simple plinth course, but generally with the English bond wall demolished down at least to it; though the wall is difficult to assess here from the photographic record partly because of Phase III and IV structures in this area.

Some 0.61 m north east of the hearth in wall [106] a narrower wall, [108], met that wall at right angles (Pl. 9) and was said to have been of one build with it. It is relatively poorly recorded, but was traced c. 2.44 m to the south east where it returned at right angles to the north east. This return was evidently c. 3.96 m long and ‘stood to a height of 3 feet [0.91 m] in places’,<sup>13</sup> though photographic evidence suggests that it survived higher than this in some cases, to about 11 courses of English bond brickwork; and it looks to have been only about a foot (0.30 m) wide (Pl. 13).

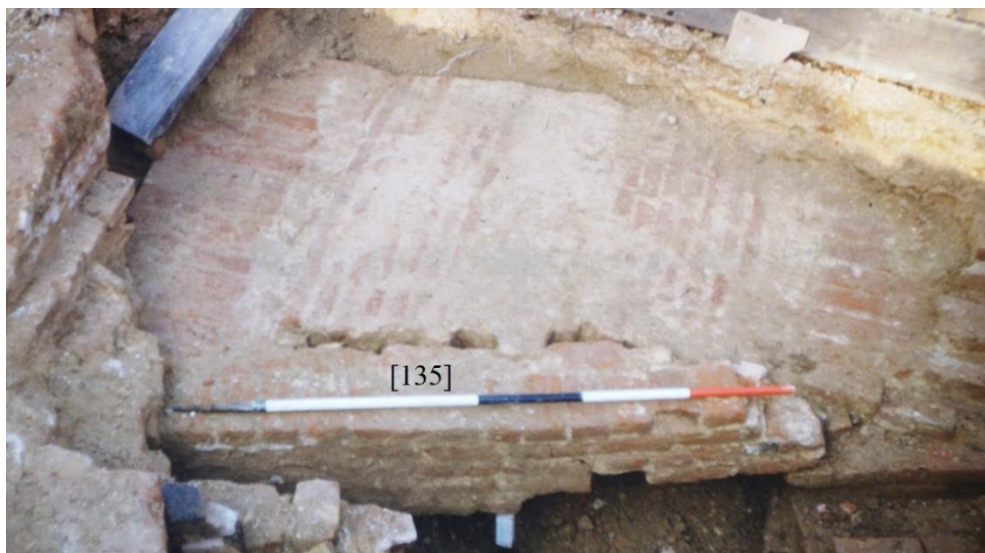
Pl. 10: Tr. L/M, Cess Pit [107], Looking North East

The same is true of some elements of the cess pit (Pl. 10) which evidently lay at the north eastern end of the wall, and according to Drayton was bonded into it. It, [107], appears to have been roughly square, c. 2.29 x 2.13 m on plans (but internally 2.03 x 1.78 m according to Drayton) and 1.37 m high below the crown of its low vaulted, single skin brick roof. The roof was built of staggered lines of south west – north east lain bricks and some site diary records suggest that the roof may have been covered by a layer of ‘clay’. The cess pit’s south western side had been truncated by the insertion of a Phase IV drain, [135], the excavators’ partial removal of which clearly caused the collapse of part of the roof and little investigation of its interior was undertaken due to its being flooded and to time constraints. Its walls were of English bond brickwork with peg tile filler courses at the wall/roof junctions (Pl. 11).

Clearly the inflow to the cess pit must have been on the south west where it was later truncated by Phase IV drain [135] and it might well have served garderobes which remained in use through Phases II and III. Whether the location of the cess pit indicates the position of the north eastern end of the Phase II range is unclear. Whilst no wall lines are recorded north east of the later drain [135], this part of the site was the last to be investigated in 1965 and photographs demonstrate that the eastern baulk of Trench L/M sloped and had only an ad hoc shoring of old doors so that excavation below the level of the roof of the cess pit to that cess pit’s south east was impossible (Pl. 12). The cess pit could therefore have projected north west of a north eastern continuation of wall [106] which had been truncated by drain [135]/lay in an unexcavated area. Indeed, the changes in Phases III and IV probably imply that by then at least the range continued for at least some distance to the north east of the cess pit.

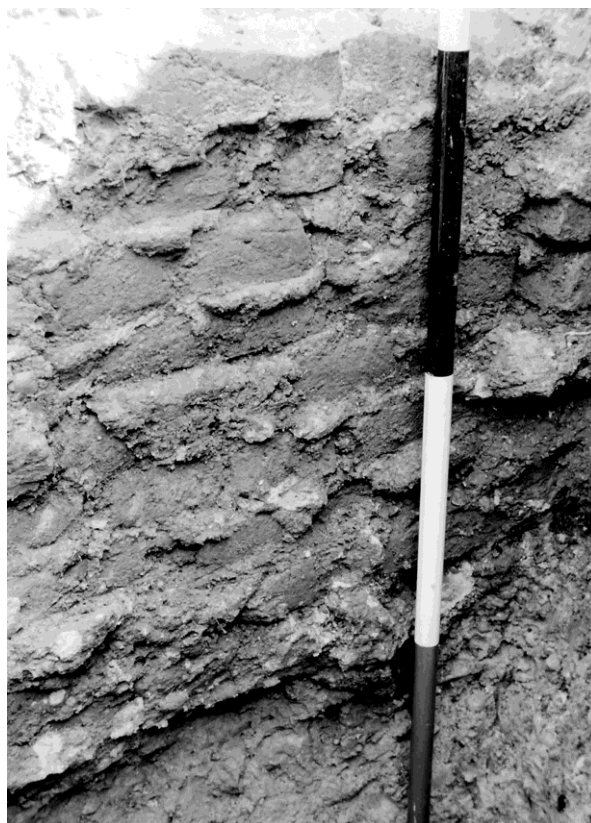
Pl. 14: Tr. O, ?North West Face of Wall [108]

Drayton believed that the walls formed two sides of ‘a cellar or similar ‘room’ as ‘the wall faces inside this ‘room’ were cleanly finished but those outside were very rough and set in clay. It would appear that this ‘room’ had been sunk into a mixture of made-up and natural earth and it is difficult to imagine it being used for anything other than storage purposes – or, possibly a cess-pit.’<sup>14</sup> The site diary adds the details that just over 0.76 m below the surviving top of the wall on the south east it narrowed, comprising only a single skin of bricks on its north west side, backed on the south by ‘grey clay with yellow streaks’, and had been ‘put in by trench building’ (Pl. 14 probably shows the north west face of this part of the wall, though it has not been possible to confirm this from the surviving archive).

This seems to strengthen Drayton’s interpretation as a cellar – though her alternative of a cess pit function seems unlikely. The site diary also notes that the north face of the wall on the south east was burnt; it was presumed at the time during palace demolition which would imply that the cellar remained in use through Phases III and IV, though that cannot be certain.

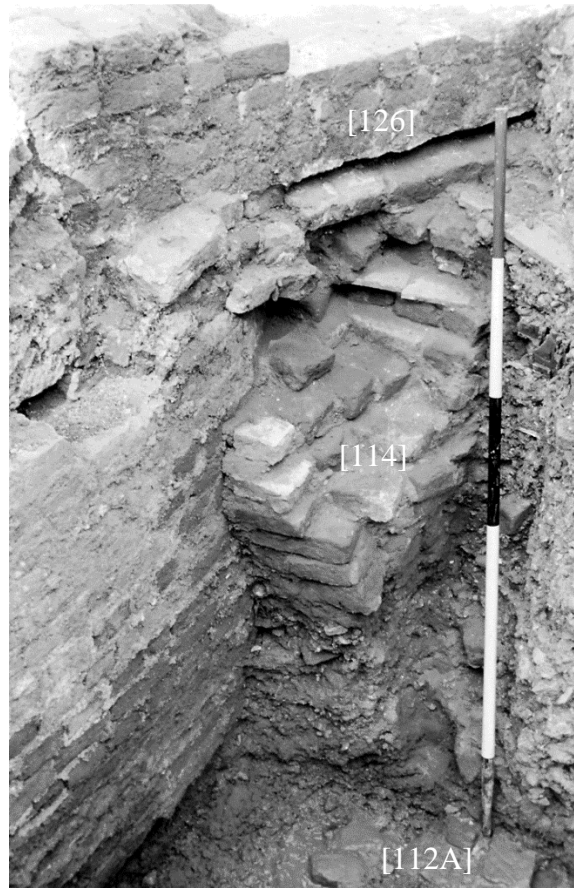
Pl. 19: Tr. D, Wall [114], Looking North East

Certainly if one relies on the photographic evidence one has to wonder whether anyone would so carefully demolish not one but two adjacent stretches of 'wall' so as to leave essentially flat surfaces at what seems to have been a considerable depth. The suspicion might be that these were in fact parts of a floor or (successive) floors, perhaps of another cellar; or even of an otherwise removed drain. In fact the site diary shows that this is precisely what [112A] at least was initially thought to be, a floor 'at much lower level than other floors already found (cellar or earlier house?)'. Moreover, photographs seem to clearly show that [112A] was not a feature that continued to the south west even to the full width of Trench D as it appears to on Drayton's published plans; rather it had a definite and original looking edge on the south west as if it and [102] were parts of the same feature. In addition, [112A] and [102] appear in fact not to show a consistent brick orientation which one might expect of an English bond built wall demolished to a given level. Not visible on any photograph, the site diary also indicates that 'a course of curved tiles – earlier drain?' were found 'where the low level brick floor [[112A]] meets the drain [i.e. wall [123] which encased the Phase III drain]'. One of the tiles is sketched and this suggests that a gutter, probably of inverted ridge tiles, may have run along the north west side of [112A]. Finally [112A] appears to lay well below the base of the wall, [114], it is supposedly the continuation of (Pl. 19). Thus, unless it is a result of incomplete excavation, wall [114] in fact looks to have been built on a rubble/soil dump probably over 0.30 m thick which lay above [112A].

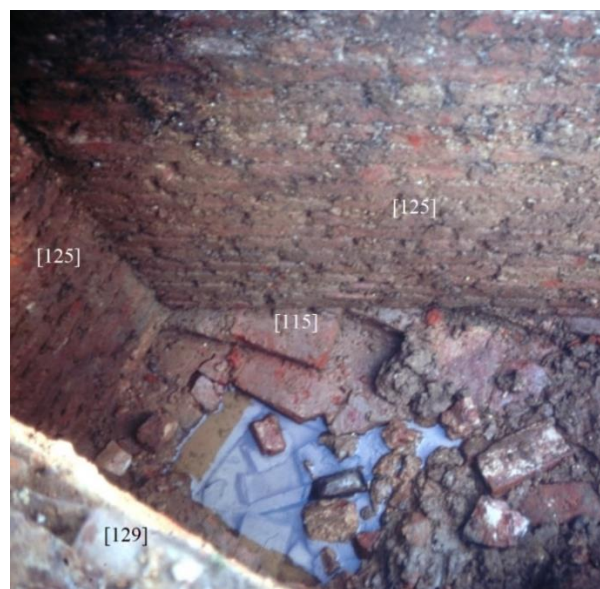
Pl. 20: Tr. B, Wall [115], Looking North

What is suggested here then is that the Phase II building's external wall turned approximately west roughly at the north side of Trench D and comprised [114] and [115]. It is difficult to say much about the latter, except that it was clearly earlier than Phase III work, because that redevelopment and a Phase IV wall ([129]) had left only a fragment of it at the very base of a very deep excavation, while excavation north west of [129] was not deep enough to have revealed its continuation. The most helpful photographs of it (Pls 20 and 21) suggest the survival of two plus courses of brickwork and show its orientation but little else.

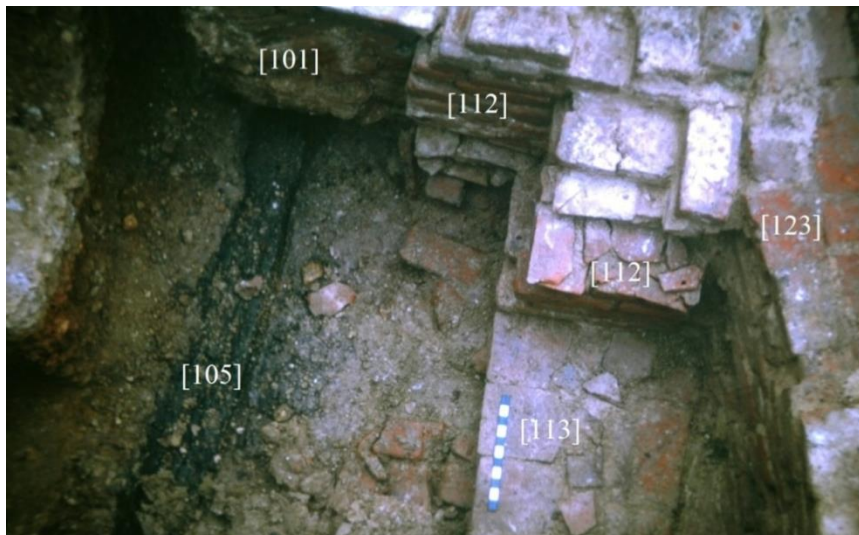
Pl. 22: Tr. F, Wall [112], Looking South

What was clearly a wall later than the Phase I wall [101], which still seems to have been in use in some form, and earlier than Phase III, did indeed run through Trench F. Unlike [106] though, the wall in question, [112], cannot have been of much structural significance unless it was originally wider (and there is no sign in photographic evidence that it had been cut back in Phase III when [123] was abuted on to it; Pl. 22).

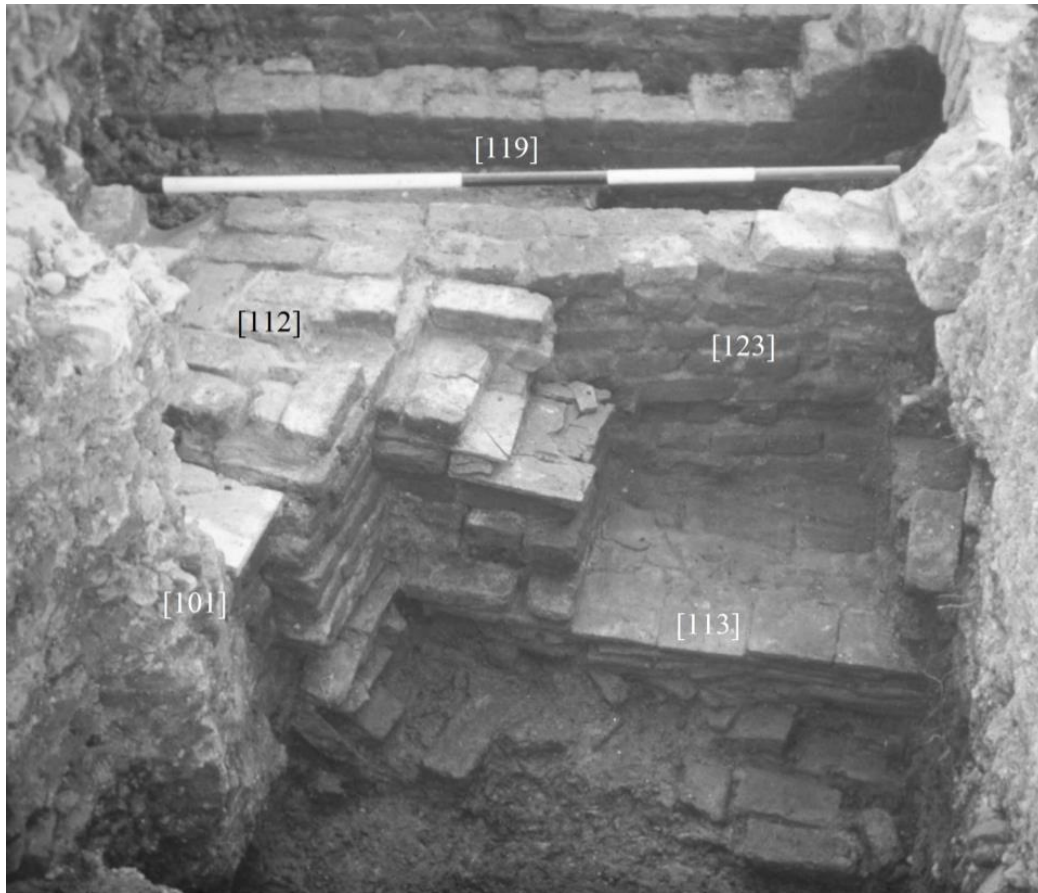
Pl. 24: Tr. F, 'Doorway' [113], Looking West

have an 'interior jamb formed of four red tiles each 9 inches square, still in situ'<sup>15</sup> as Drayton claimed. Even her published photograph demonstrates that the tiles forming the supposed threshold were only roughly broken at one end and better photographs show that they were part of the top (of otherwise no more than small irregular tile fragments) of three or four courses of tiles forming part of a basal offset of the wall (Pls 22, 24 and 25), probably with the gap between the back of the 'doorway' and the face of later wall [123] infilled with stretcher laid bricks. Indeed, these photographs appear to show these offsetting tile courses continuing into the undisturbed wall to the south of the 'doorway'; while quite obviously another at least two courses of tiles had been used further up this wall which seems unlikely at a doorway. Moreover, the doorway would seem to be set rather low down to be convincing, at least as any form of doorway through an external wall.

In fact wall [112] was clearly built, presumably in Phase II, to abut Phase I wall [101] (Pl. 4). It seems to have survived to seven courses of English bond brickwork above the basal tile offsets, probably with another small offset at the highest surviving course, and had been built into a rectangular slot cut into the west face of [101]. One suspects that what was being created was a new internal room/cellar, the remnants of a possible brick floor to which (if it was not an earlier feature) may have survived just in front of [113] (Pl. 25).

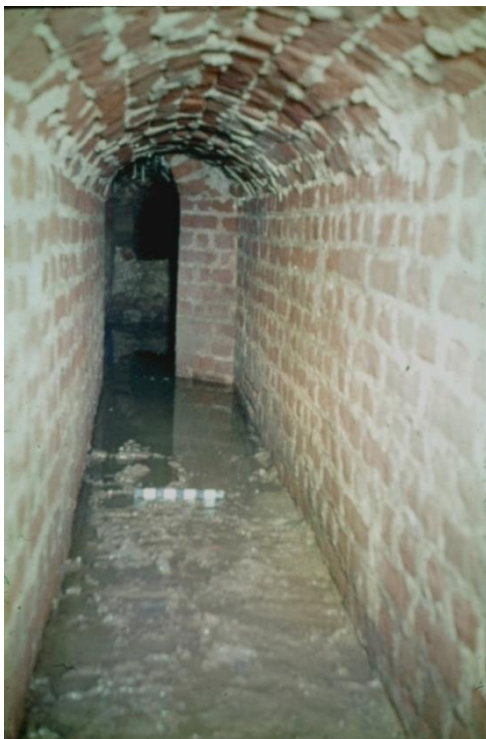
Pl. 29: Drain [118], Looking North East from the North End of [120]

The enclosed, brick floored drain (Pls 29 and 30) is described by Drayton as having a vaulted roof, internally 0.97 m high at the crown and 0.79 m at the sides, 0.53 m wide in some places and 0.41 m in others. It seems to have had sides of 11 courses of rather irregularly bonded brickwork and an 11 brick wide vaulted roof. From the northern end of the more northerly open section ([120]) it apparently ran north north west for about 0.76 m before turning to run north east (Pl. 29) for about 5.18 m to a right-angled dog leg to the west (Pl. 30), in order to avoid the Phase II projection accommodating fireplace [110], before continuing north east for a further over 10.06 m.

Two recesses within the drain were noted probably on the west side, one at the change of direction and one at the dog leg, '3' 10" [1.17 m] long, 1' [0.30 m] high and 4" [0.10 m] deep (the gap made by omitting the bottom three courses of bricks)'.<sup>18</sup> Drayton thought that these were to hold tools, but that seems highly unlikely if the recesses were at the floor level of the drain and it is far more likely that they gave additional width to the drain at the points where it changed direction to prevent any 'backing up' of the flow. (Drayton also thought that the drain had been flushed by a stream because it was so clean, but there are no water sources that could have been used for this, besides it is now known that some palace drains have continued to take a rainwater flow into Maidens Brook into modern times and this has probably continued to prevent significant silting.)

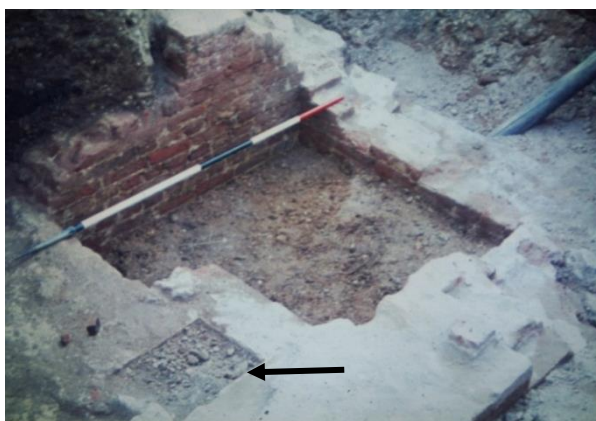
Pl. 31: Tr. K, Tower [116] with Chute [121] Arrowed in the Foreground, Looking North West

At least within the excavated area the drain probably originally served two garderobes. One – likely at first floor level or above - is clearly indicated by the rectangular chute [121] which was built into a thickening of the south eastern side of the smaller tower ([116], below). It was 0.41 m square (Pls 31 and 43) and sloped from north west to south east into the drain within which (?demolition) debris that had been tipped down it was found mounded.

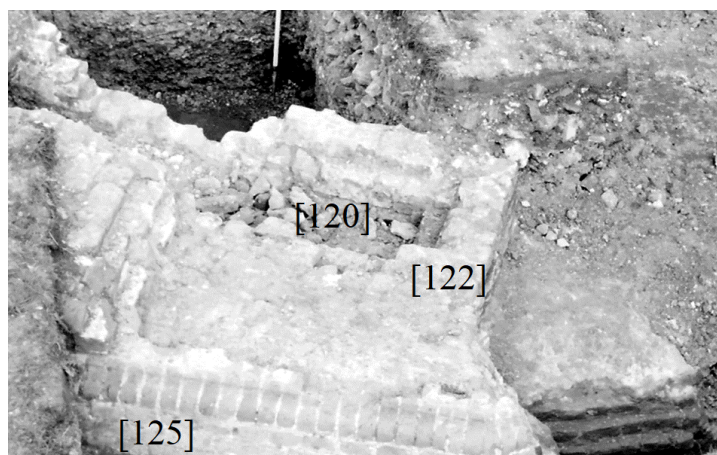
Pl. 34: Tr. D/F, Roofed Section of the Drain (to the Right of [122]), Looking South East

unstruck joints on the south face of [122] imply that at least at the level preserved this face was probably either buried or concealed (Pls 32 - 35). This probably adds to the suspicion that the garderobe itself – contra Drayton’s belief – lay at first floor level or above. How long the roofed section of the drain was is a little ambiguous; some site diary records might be taken to mean 0.91 m while Drayton gives ‘about two feet [0.61 m]’.<sup>20</sup>

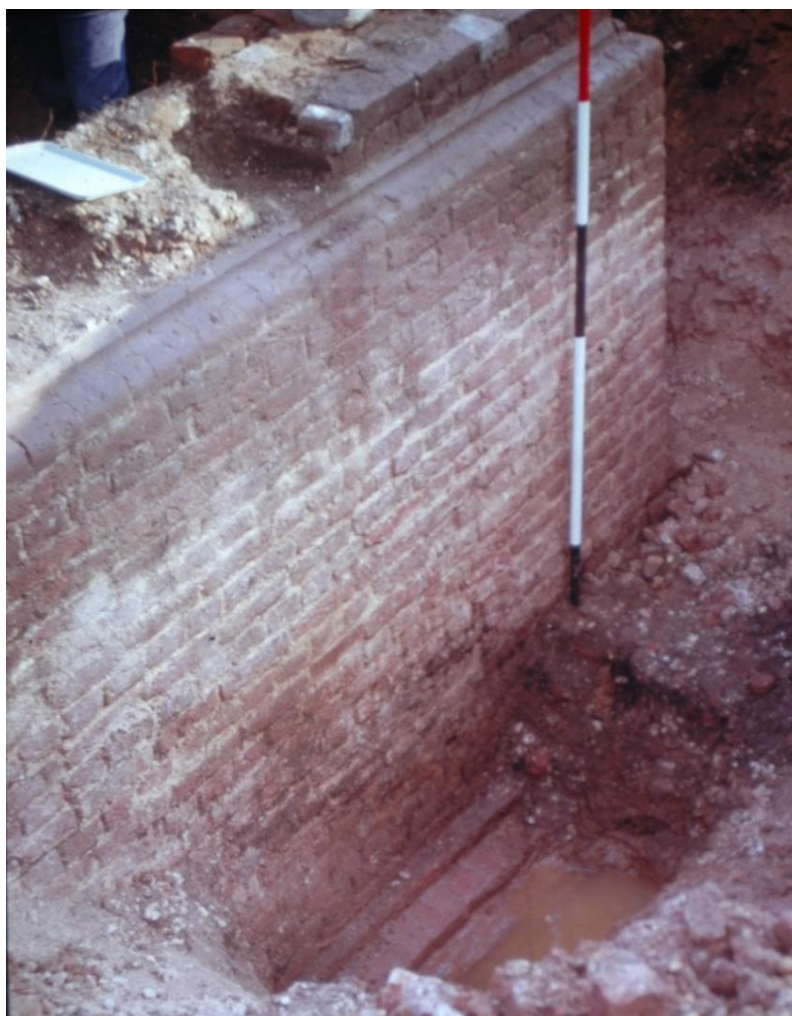
Pl. 36: Tr. B, North West Face of Tower [125], Looking South

The tower itself was 4.27 m wide externally and projected from the facade wall by 2.29 m according to Drayton (though published plans show it as nearer to 2.13 m). But internal dimensions are at variance in different records. Published plans give a width of 2.74 m and a depth of 3.05 m; Drayton says 3.20 m by 2.90 m. The site diary gives 0.69 m for the width of the north east wall and published plans seem to agree and show all its walls the same width. Externally the wall was cleared as far as one or more, presumably basal, offsets in two places, in the centre of the north west face and in the angle formed by [117] and the later wall [129] (Pl. 36; and see Pl. 21).

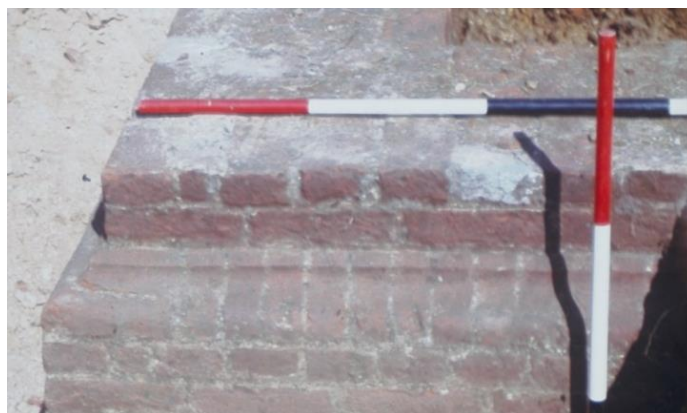
Pl. 37: Tr. B, Moulded Brick Plinth at the South West Corner of Tower [125], Looking North East

This showed that it survived to 1.83 m (according to Drayton) comprising basal offsets, then 24 courses of English bond brickwork up to an offset at a moulded brick plinth course (continued to the south west on the west face of the tower) and in places two courses of English bond brickwork above it (Pl. 37). Only two small basal offsets are obvious in the angle between [117] and [129], but on the north west at least two larger ones, the lower appearing to be of downward sloping headers, can be seen on Pl. 36 and the site diary notes 'six shallow steps'. The tower's construction appears to have been of fair inner and outer skins and a rougher, often part brick core to judge from photographs (Pl. 38) and this was continued in the integrally built section of wall abutting and running south which again had an offset at a moulded brick plinth course below the two highest surviving courses of its English bond brickwork.

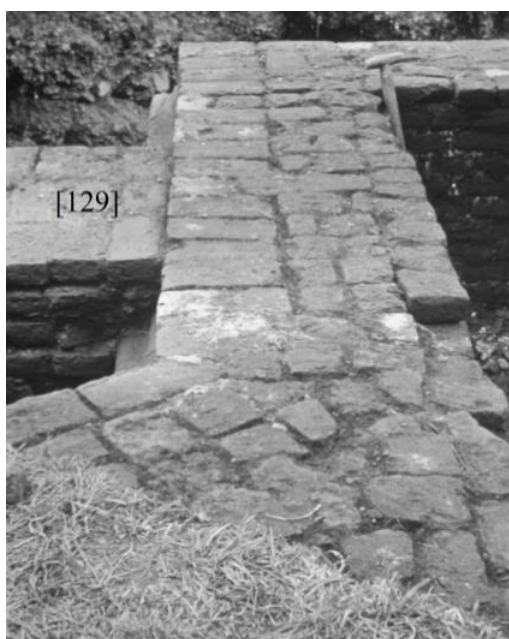
Pl. 38: South West Side of Tower [125], Looking North West

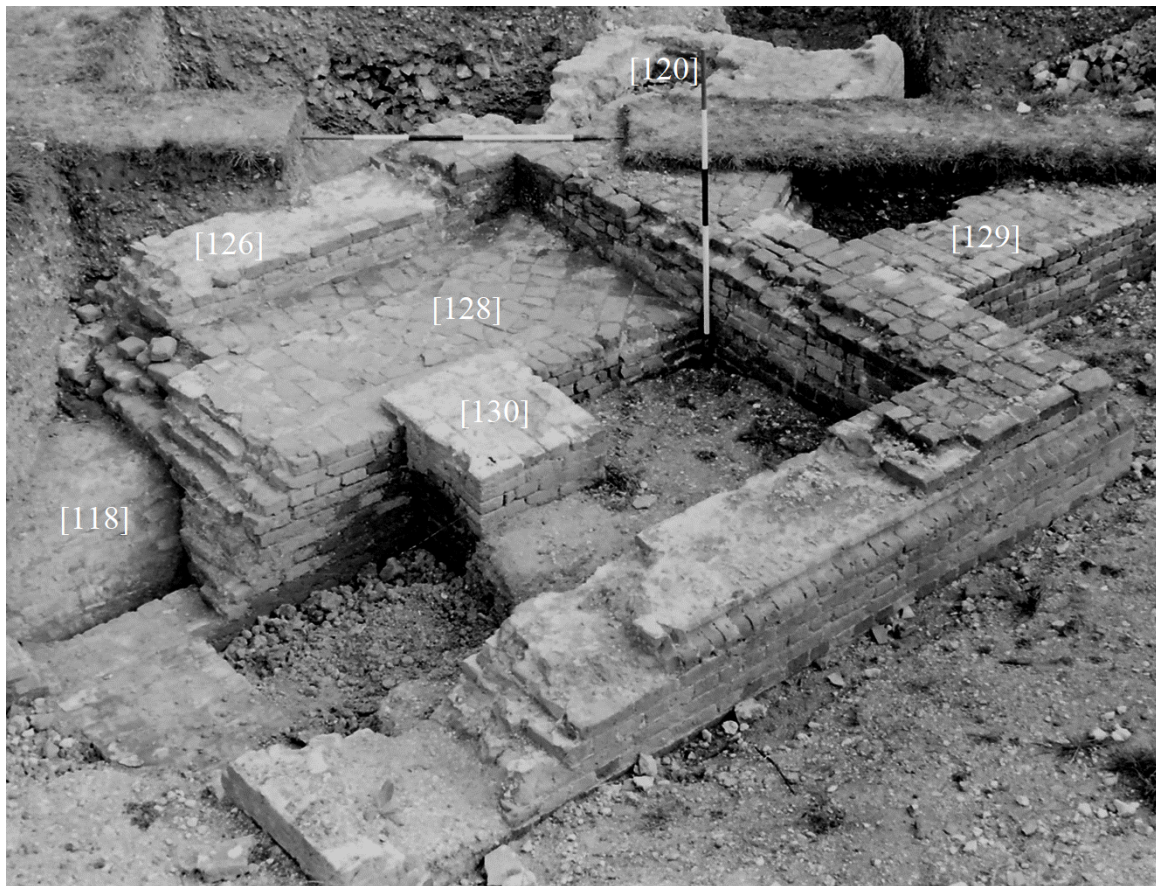
Pl. 39: Tr. B/C/D, Tower [125], Looking South

The back (south eastern side) of the tower was marked by [126], an English bond brickwork wall built over [114] as part of [123], the wall encasing the south east side of the drain (Pl. 39; see also Pl. 19 and Pl. 40). It survived to a lower level than the south west and north west walls of the tower and had been completely demolished at its north east end as part of a more thorough area of demolition (referred to by Drayton as the arch) that removed both the encasing walls of the drain ([123] and within/north east of the larger tower [127]) as well as much of the north east wall of the tower (Pls 39 and 41; see also Pl. 26). Given that this was the only part of the complex demolished to this extent, and the likely amount of work involved, unless conceivably the area had already been subject to some collapse, one might well ask what necessitated this demolition, but no reason is immediately obvious.

The south eastern half of the tower did have a floor surface [128], comprising the top of the at least nine course English bond brick walls ([123]/[127]) encasing the drain (Pls 39 - 41). Drayton gives its north west – south east width as 1.60 m and believed that ‘at some time extensive repairs had been carried out, with flooring tiles replacing the bricks in an area indicating exactly the position of the vaulted drain running underneath’.<sup>21</sup> However, it does not look as if this (peg not flooring) tile fragment floor is matched by any disruption to the brickwork encasing the drain where it was exposed by demolition and it does not in fact follow the line of its apex but one along its north western edge, at least until it turns to the south. If it did derive then from drain repair work, that repair work must have been to the side of the drain and the tile fragment ‘repair’ to the floor have been more extensive than most of the work. This seems unlikely. A second distant possibility is presumably that a garderobe chute had been blocked here, but that does not seem likely as the band of tile fragments turns at an angle, blocking one would not disrupt other areas of the floor and presumably its egress would have been apparent when the drain was explored. A more attractive possibility is that what was represented was the blocking (?in Phase IV) of a superficial feature

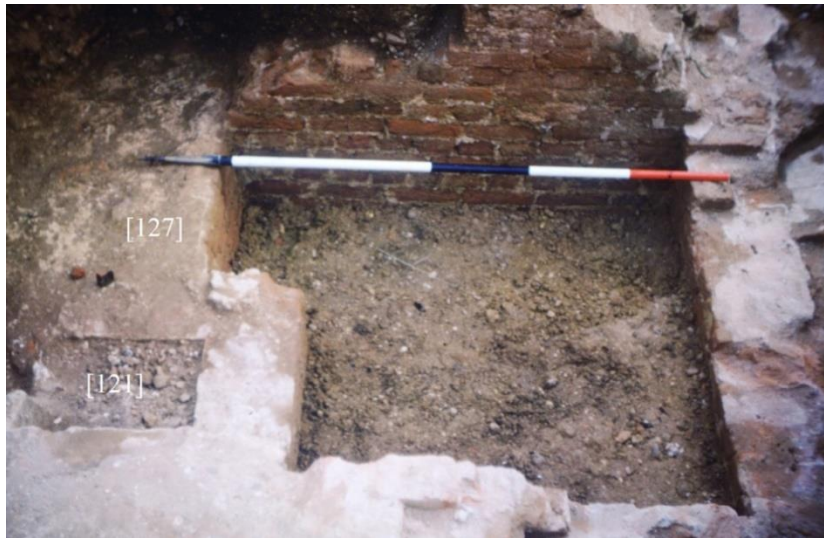
Pl. 43: Tr. H/I/J, Smaller Tower [116], Looking North West

According to Drayton the smaller second tower, [116], (Pl. 43) projected 1.98 m from the facade and was externally 2.44 m wide and internally 1.22 m square (though it is shown a little wider on published plans and site diary figures for wall thickness suggest 0.56 not 0.61 m thick walls). But the facade wall/back wall of the tower had been broadened by 0.23 m for a distance of about 0.53 m at its south east corner to accommodate the chute, [121], probably from a (?first floor) garderobe within the tower and which communicated with drain [118]. The broadening had an offset to its south west face (Pls 44 and 45) which, together with some bond irregularities and possible signs of unstruck joints on photographs, probably suggests that the majority of the surviving walls were effectively foundations below ground floor level. The tower survived best on the south west where over 17 courses were preserved, but the only indication of its function is the chute and one wonders how far it served as much more than the location of a (?first floor) garderobe.

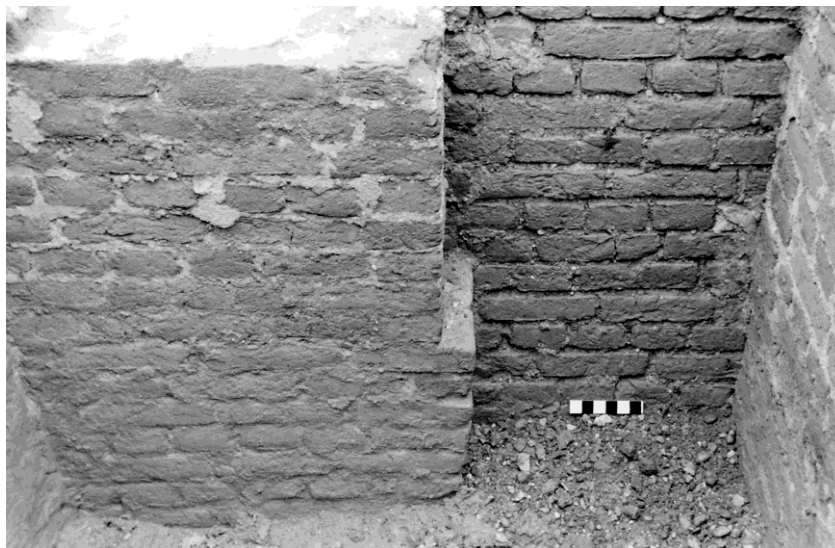
Pl. 44: Tr. H/I/J, Smaller Tower [116], Looking South East

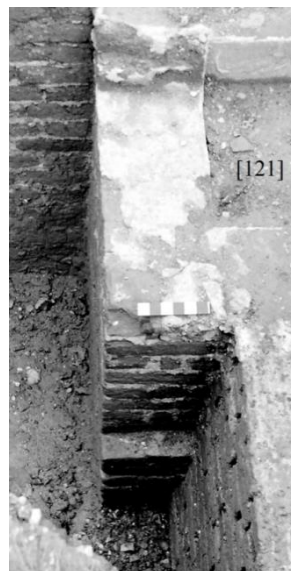
Pl. 45: Tr. H/I/J, Detail of the Expansion for the Garderobe Chute [121]

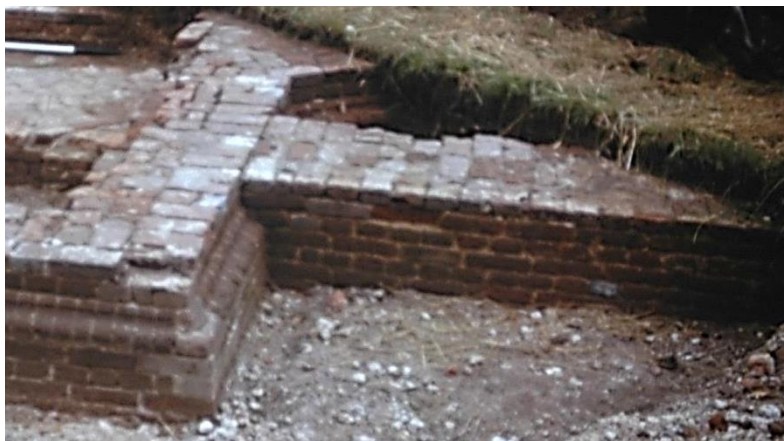
Pl. 46: Tr. B, Wall [129] Running South West from Tower [125], Looking South East

One addition made was wall [129] which clearly abutted the south west side of the larger tower [125] and ran south west from it for over 2.13 m (Pls 46 - 48; and Pls 20 and 39). Built of English Bond brickwork, about 0.70 m wide and surviving to over 22 courses, it seems to have had a part-brick core faced with single skins of fair brickwork like [125], but Drayton commented that it was of ‘noticeably inferior brickwork’<sup>23</sup> to the tower. It was clearly a load bearing structural wall, but the decorative plinth of [125] was not continued along it which confirms that it was a later addition to the Phase III scheme. The implication would seem to be that the range was extended to the south west at some point and presumably [129] was the external north western wall of the extension, but too little of the area crossed by the wall was seen to go further than this.

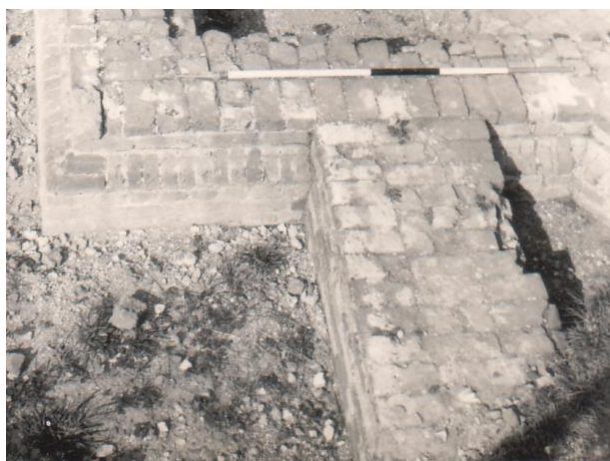
Pl. 47: Tr. B, Wall [129] Running South West from Tower [125], Looking North East

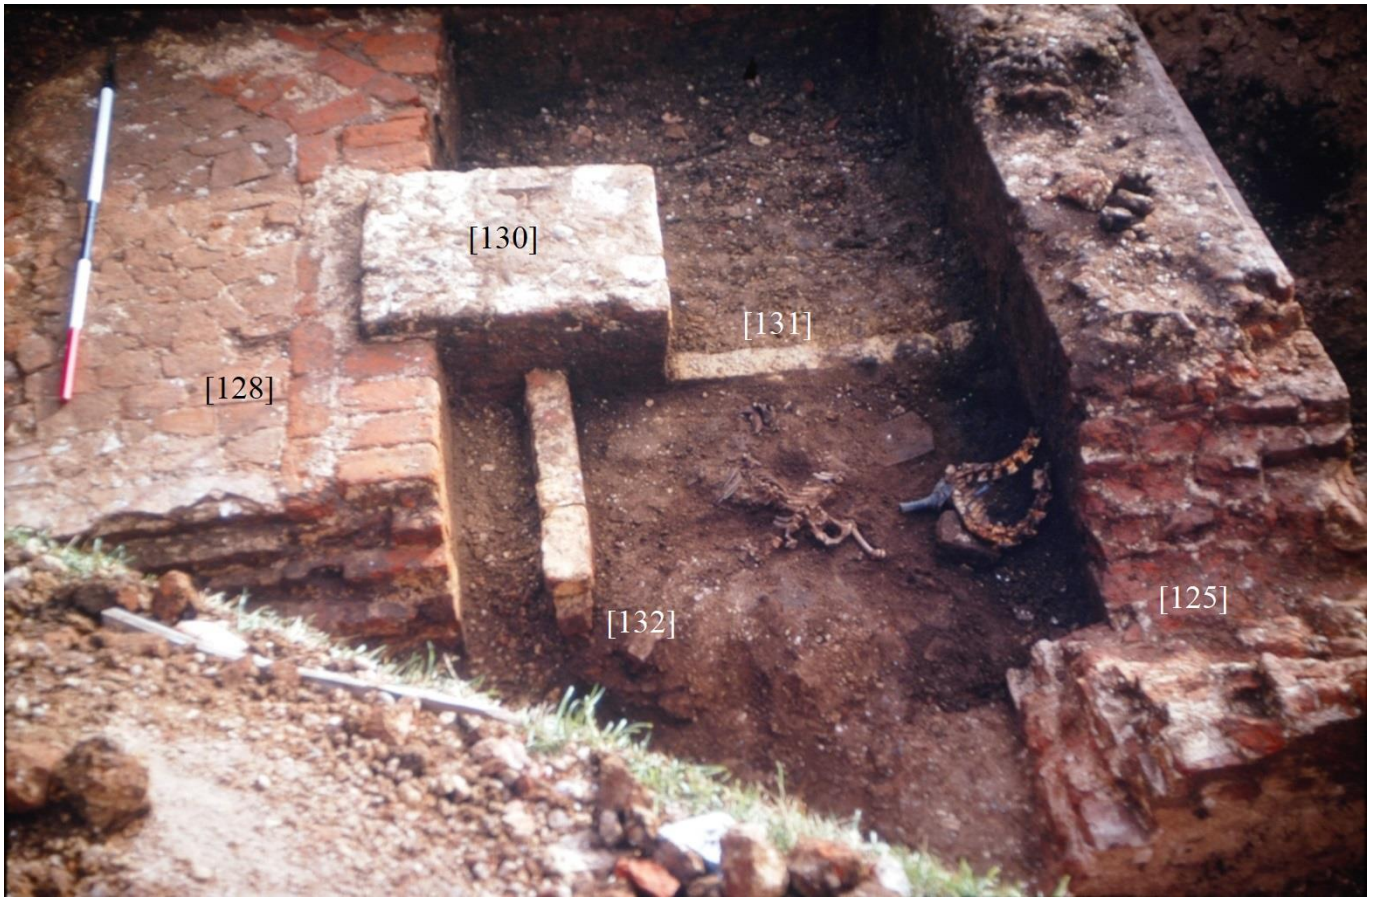
Pl. 50: Tr. B/C, Midden in Tower [125], Looking South West

Whether contemporaneously or later the tower was then subdivided by the building of two dwarf walls, [131] and [132], abutting the north west and north east faces of [130] and running up to the inner faces of the tower's main walls (Pls 49 and 50). They appear to have been one skin mortared stretcher laid brick walls of at least three courses, [132] surviving at least to one course higher than [131]. Clearly they cannot have been more than partition walls and may only have been the seatings for wooden screen walls under the putative staircase, but at some point at least a midden seems to have developed, probably at least mainly within the 0.91 x 1.22 m space that they defined. Whether this was within the life of the palace or during its demolition it is impossible to say, but it appears that the walls bounded it and if so it would more likely belong to the former period. The midden (Pls 50 and 51) included partial articulated dog and Roe deer skeletons, at least one semi-complete glass vessel and probably much of a very large Border Ware (BORDY) pipkin (see the main volume text pp 287; 258 (No. 19.9); and 279 (No. 60.1)).

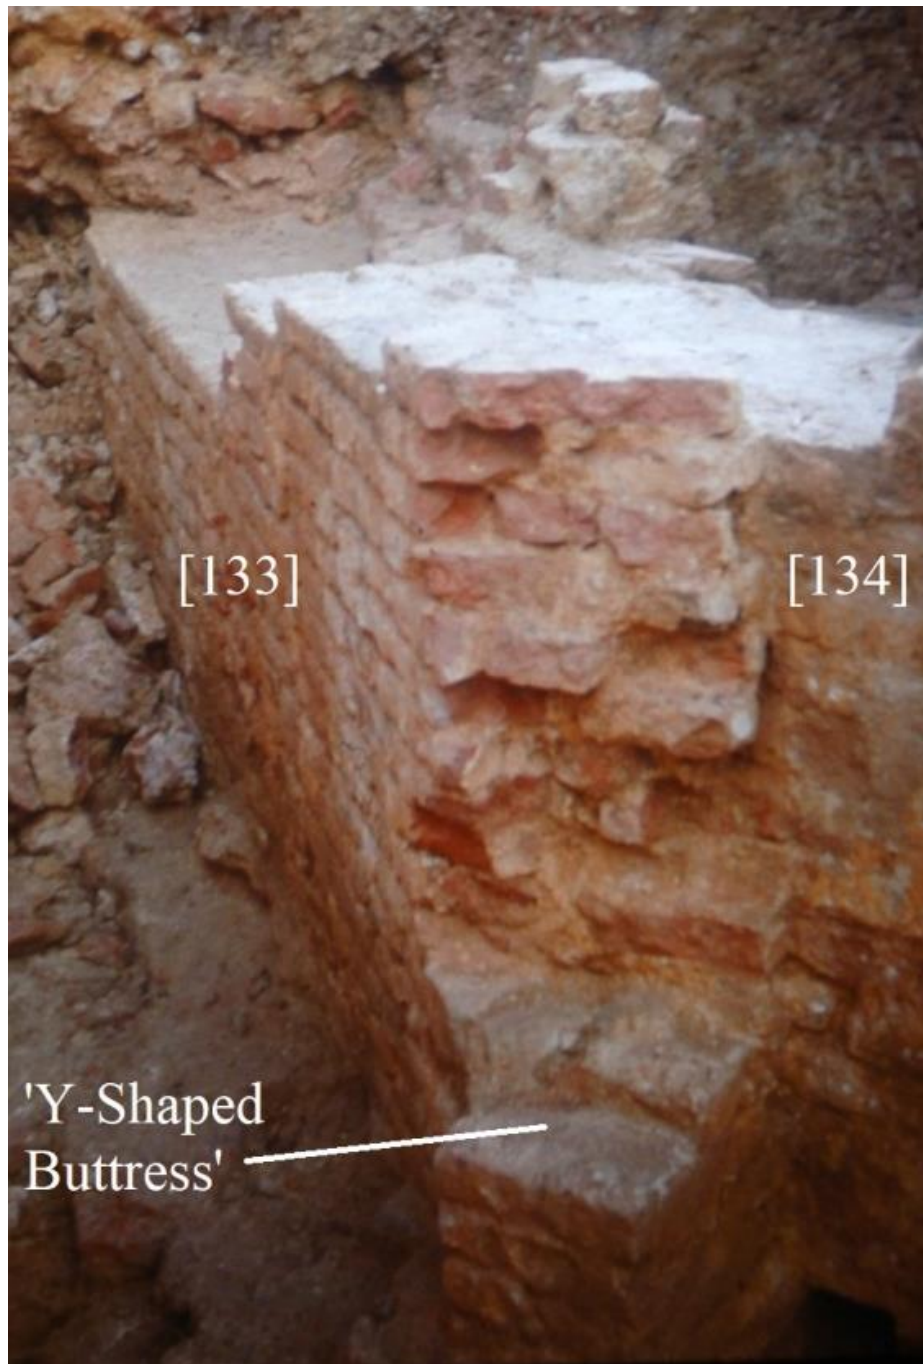
Pl. 53: Tr. P, Wall [133], Looking East

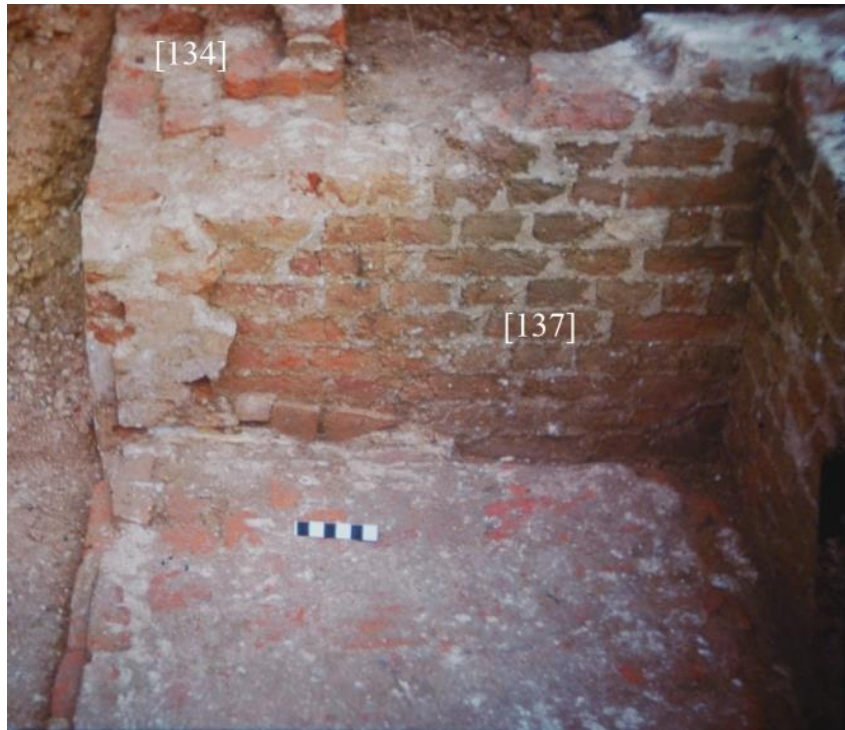
Pl. 59: Tr. L/M, Cupboard [136], Looking South East
