# **Monarchs, Courtiers and Technocrats; Elsyng Palace, Enfield: Place and People**

**The Documentary and Archaeological Evidence for a Fifteenth to  
Seventeenth Century Courtier's House and Tudor and Stuart Royal  
Palace; and for the Lives of its Owners and Households**

## **The 1963 – 6 Excavations: a Description and Re-evaluation**

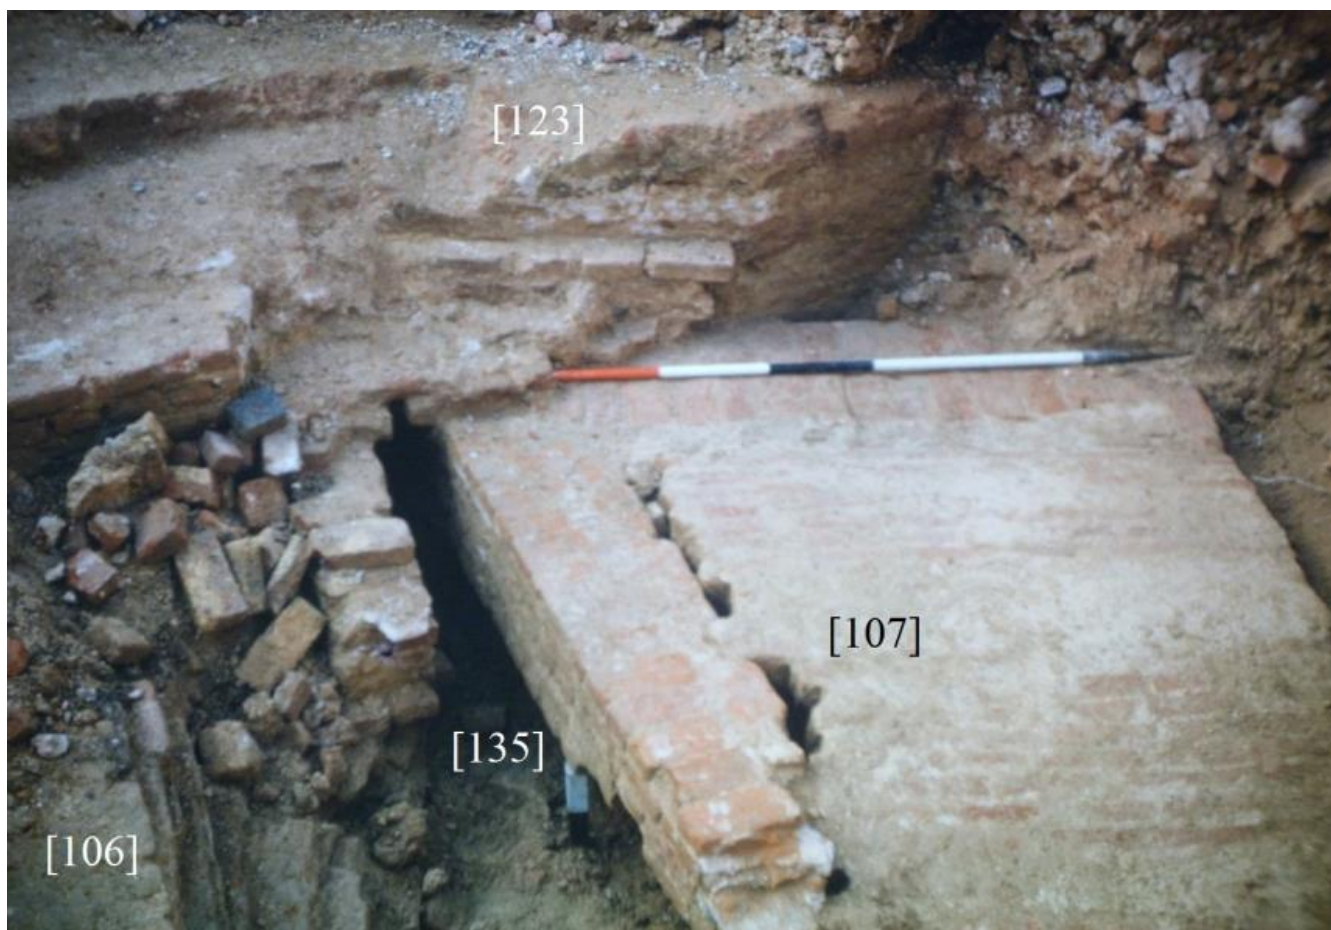
Pl. 61: Tr. L/M, Drain [135], Looking North West

However, both sides of the drain were of more substantial construction at the north west end (Pls 10 and 61) where the drain ran across the south west side of the former cess pit [107] and into the Phase III drain via a roughly cut keyhole shaped hole in its encasing wall, [123]. Here its north east side especially had been broadened and carried up to a height of ?five courses to fill a ragged gap left, one presumes, by the removal of a chute into the cess pit when it went out of use; and here the drain narrowed a little and changed orientation slightly. The drain evidently continued south east across the remnant of wall [104] at the very edge of excavation and so presumably served the area south of that excavated in which wall [133] indicates there were further structures, though it need not necessarily have served the interior of a structure and could have been e.g. a roof water drain.

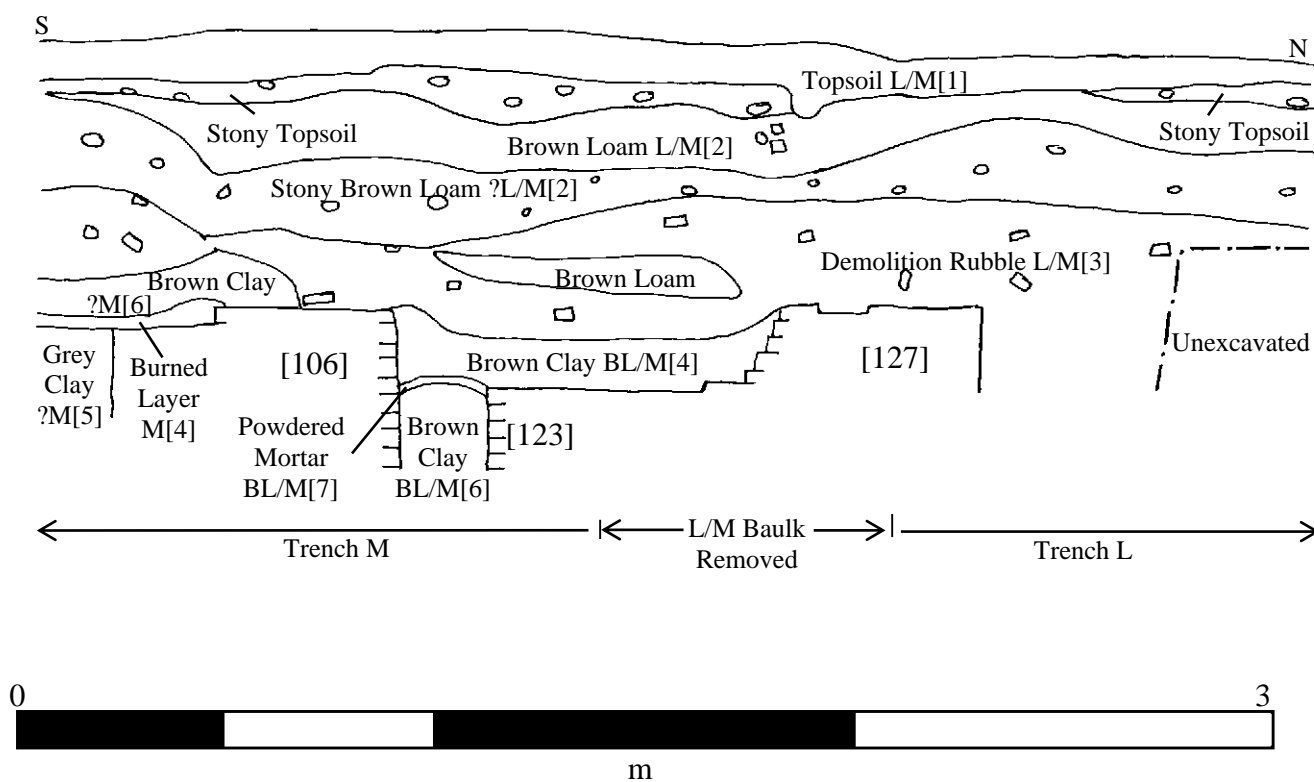
Fig. 9: Trench L/M, West Section

An exception though is where evidence of a large, presumably demolition, bonfire appears to have been encountered. Thus, though the eventually contiguous Trenches H, J, K and N all seem to have had some sort of demolition rubble deposit and a 'Brown Loam' ?landscaping deposit, in the south east of Trench K there was probably a separate deposit of burnt material, stretching into the south west corner of Trench L/M and into Trench O (though not in an area where a drawn section survives) and probably deriving from a palace demolition bonfire. The one surviving section to show this is of Trench M (Fig. 9), where the 'Burned Layer' (M[4]) lay partly over demolished wall [106] as did a 'Brown Clay' (?M[6]) which probably capped it off. The site diary identifies M[4] (though not by this designation) as 'a thick black layer' with 'burned clay and tiles' at its top and it evidently lay above a Grey Clay (M[5]) filling the top of the Phase II cellar (though the excavators appear to have thought that this was a clay floor, probably not having excavated below it where records from other trenches suggest the cellar was filled with demolition rubble). Useful as this is in suggesting that much of the Phase II structures such as wall [106] remained in use until the demolition of the palace, little else can be learnt from these late deposits.
