# **Monarchs, Courtiers and Technocrats; Elsyng Palace, Enfield: Place and People**

## **The 1967 (and 1970) Gas Main Trenches: a Description and Evaluation**

### *The Features Recorded in the 1967 Gas Main Trench (MJD with PD)*

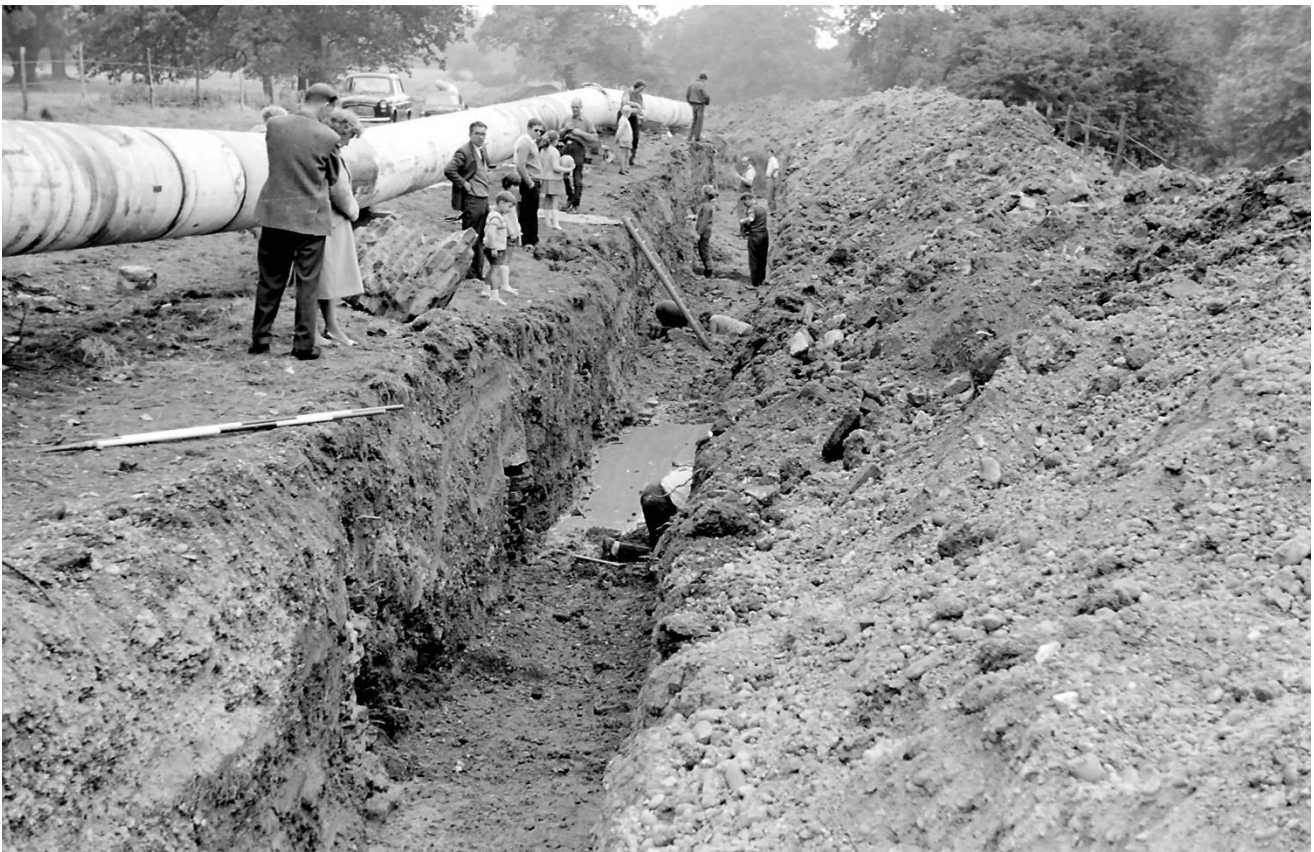
Pl. 1: The Gas Main Trench Looking West with [160] in the Foreground (Left Section) and Drain [159] Opposite the Nearest Excavator. The Flooding is in the Area of Walls [157] and [158].

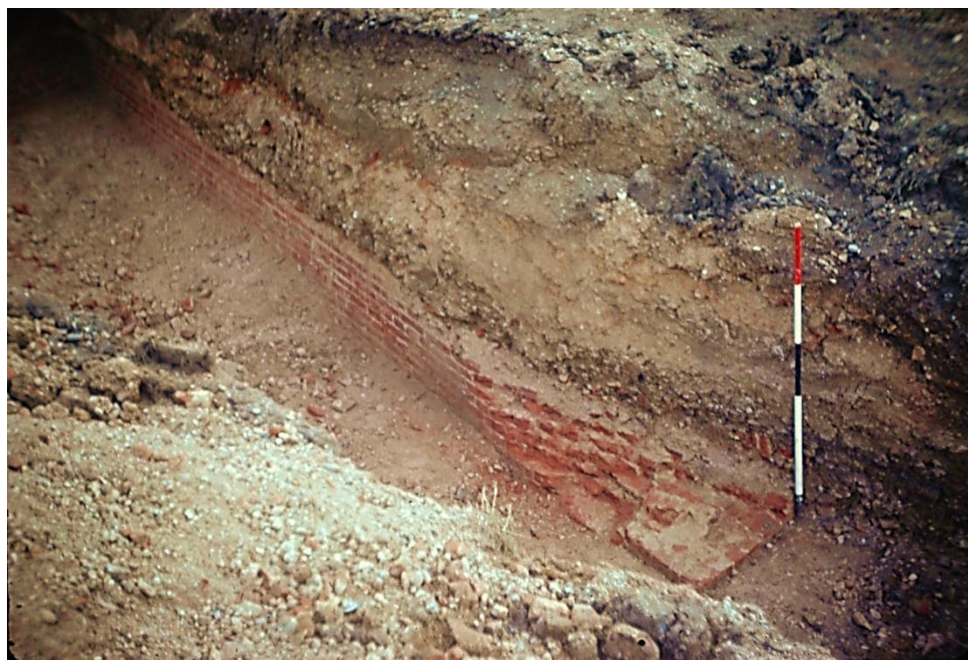
Pl. 2: Wall [150] Looking South and Showing the Point Where the Machine Cut Turned, Truncating its Corner.

Further west both the internal and external angles of [150] bond (Pls 2 - 4) and it seems likely that this structure represents a room extending west beyond the general line of buildings found in 1963 - 6, with a garderobe projection or tower serving it on the north side, as Drayton indeed seems to have believed. The area between [150] and [152] can be identified as a garderobe pit with an internal pier terminating in a spine wall ([151]).<sup>28</sup> This is consistent with the tops of the surviving truncated walls found being considerably below the ground floor level of the buildings of which they formed part, but well above their foundation level which was nowhere recorded. There are no photographs of [151], but Pl. 4 shows the interior of the pit filled with relatively loose rubble over (from the visible section) what seems to be a fill accumulated in use. The east side of this pit will have been formed by [152], perhaps deliberately demolished only to a level where it could serve thus, and the pit would be in line with the major drain [118] found in 1963 - 6. If this drain flowed into and through the garderobe pit it would, as noted above, explain why this drain was not obviously represented in the gas main trench and suggest that structures [150] - [151] and [153] - [156] belonged to site Phase 2 (Drayton's Phase III; i.e. probably the remodelling by Sir Thomas Lovell) or later.

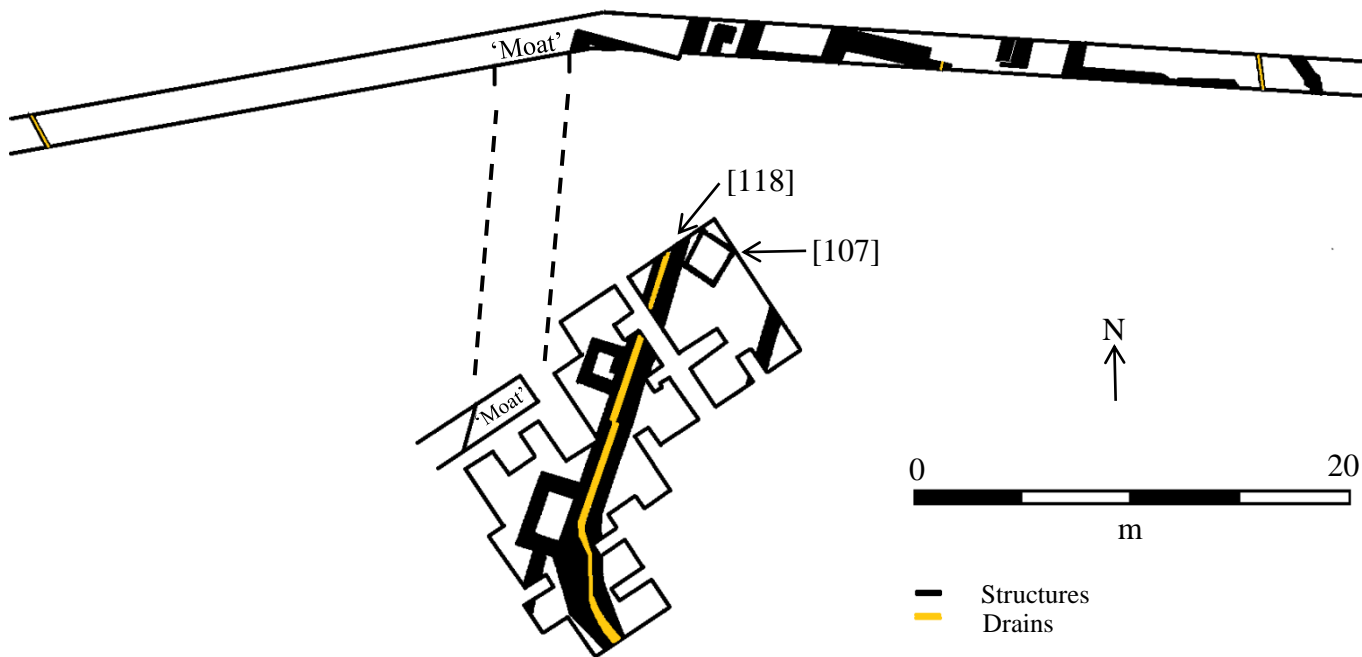
Fig. 1: Probable Relationship Between the 1963 – 6 Excavations (Only Selected Features Shown) and the 1967 Gas Main Trench Recording

probably lay at least very approximately in the positions shown on Fig. 1; and that they match the orientation of the structures excavated in 1963 – 6 far better than on Drayton’s plan appears to add to the likelihood that this is very broadly the correct relationship between the excavated and rescue recorded areas.

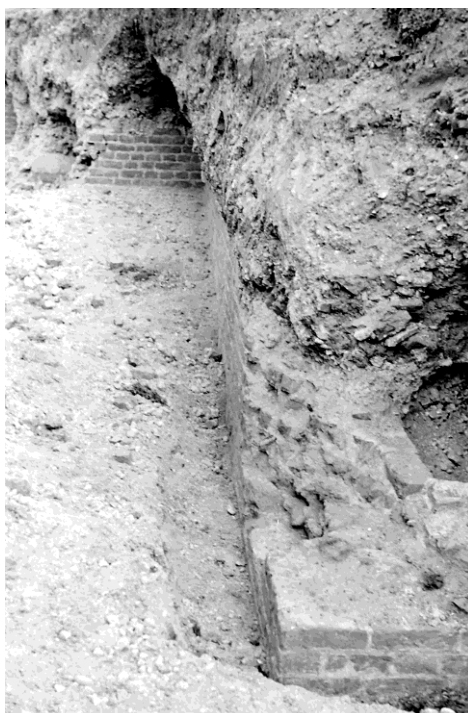
Pl. 3: Wall [150] Looking East.

Drayton presumably interpreted feature [150] (Pls 2 - 4) as a tower projecting from a north south running exterior wall as it seems to have lain on the edge of [163], which she took to be a moat. Not unreasonably, she presumably saw it as complementing those fully known towers further south (1963 - 6 work [116] and [125]) and may have envisaged it as a continuation of the north west facade of the range partly excavated in the preceding years. Its walls seem to have been c. 0.58 m thick, but it would be far bigger than the two other towers. Around 1.20 m or so further east [151] appears to have been a 0.43 m wall running north to end in a 0.97 x 1.13 m square of brickwork on its east, but no more is known about it from site records, though it must have lain just out of shot to the left of Pl. 4.

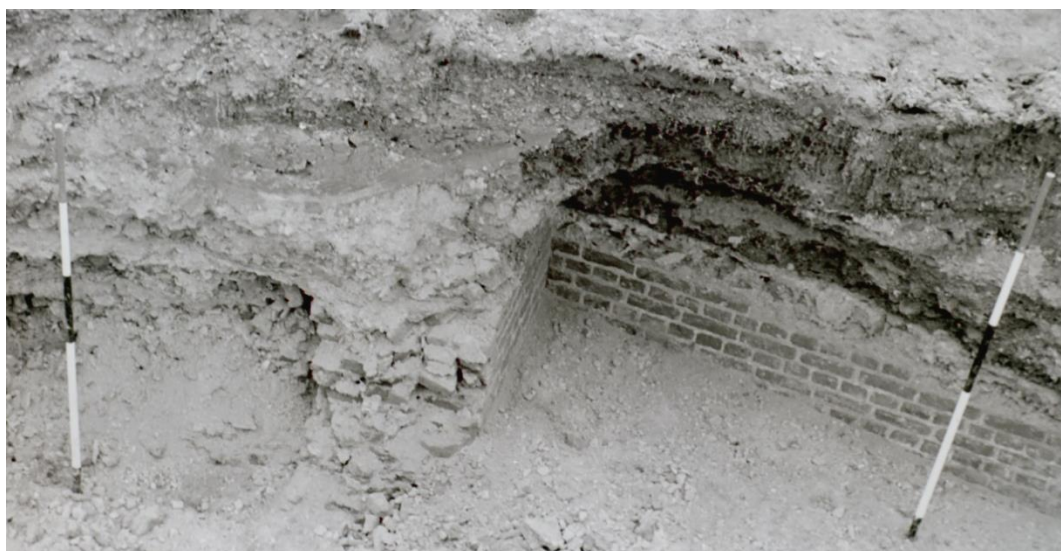
Pl. 4: East End of Wall [150] Where its Return to the North was Machine Truncated, Looking South.

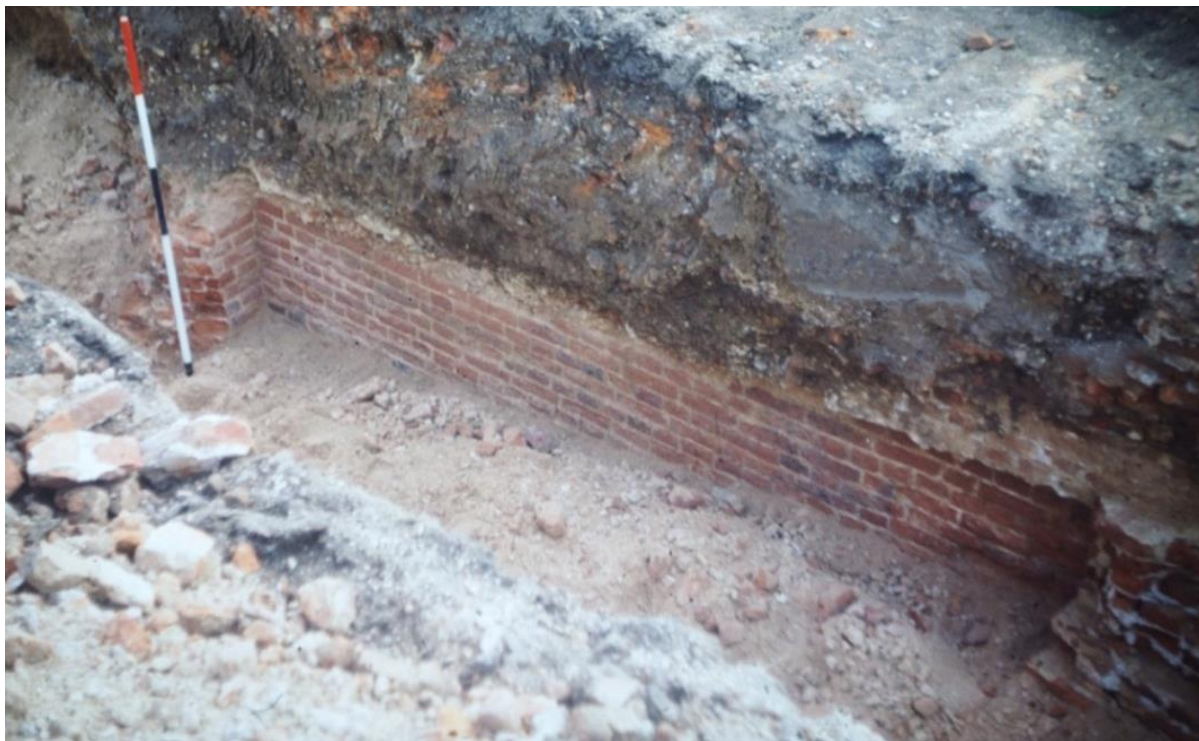
Pl. 5: Walls [152] on the Right, [153] and on the Left the Stub of the Western End Wall of Structure [154] with [153A] above [152] and [153], Looking South.

Only 0.61 m east of [151] was [152], a 0.79 m thick wall which Drayton may have thought was of her Phase IV. Be that as it may, it clearly abutted rather than was bonded into an east west wall, [153], also marked as Phase IV on published plans, about 3.84 m long (Pls 5 - 7).

Not mentioned by Drayton (unless this was what she identified as her Phase IV modification) the drawn section (Fig. 2) and photographic evidence (Pls 5 and 7) also indicate a section of walling ([153A]) survived above and so was later than [152] and [153].

The function of the structure represented by [153]/[154]/[155] is unclear. Photographs show that [153] and [154] bonded (Pl. 5), as probably did the thicker section of [154] to [155], the section with the small opening (Pl. 8), forming an integral structure extending east from its abuttal with [152]. The projection, [154], could, if [153] continued east to close it on the south, be a garderobe pit, or a large fireplace (c. 3.26 m wide internally) if it did not. Perhaps more likely though, given the stepped projection [155], it had a combination of these functions.<sup>25</sup> The small opening in [155], at a low level, appears to be cut, very neatly, through a wall, with no sign of a drain leading from it, and its invert apparently falling to the south against the slope (Pl. 8). Thus, rather than a drain, it is perhaps more likely that it allowed the passage of a lead water pipe. Similarly, [156] (of which there is sadly no photograph) resembles a pipe duct, if recorded rather wider than the c. 0.75 m one might expect with single brick walls to the duct.<sup>26</sup> It is then possible that a water supply pipe emerged from [155], turned to the east and was encased in [156] as it turned again to the north. It might just possibly have served a fountain on a terrace to the north.<sup>27</sup>

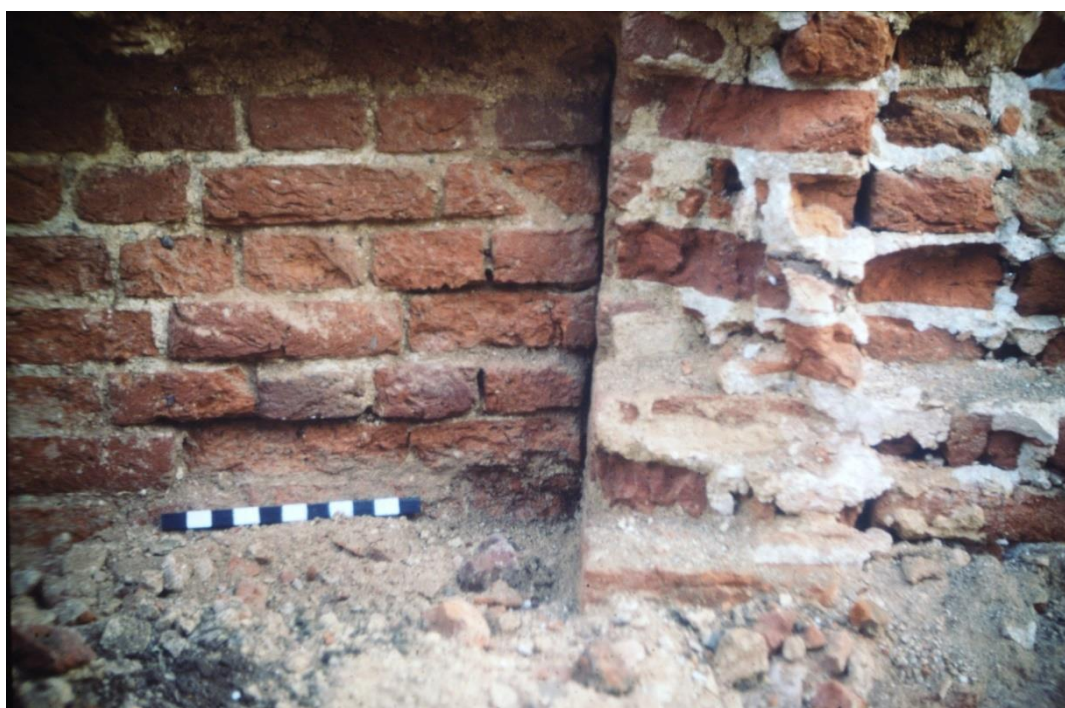
Pl. 6: [152], on the Right, Abutted by [153], Looking South

Of the building fragments west of such a moat those contemporary with it (so of Phase A) would appear to be [152], [157] and [158]. In contrast to the well-preserved walls further west, the remains of [157]/[158] seem to have been almost completely robbed.<sup>18</sup> [157] comprised only the lowest, footing course of the brick wall, with what should be the first course of the wall proper in the side of the trench; the same is true of [158] (Pls 9 - 10). Thus, whether or not the original superstructure of these walls was similar to that of [150] – [155] further west (and it probably was), their demolition history was very different. Moreover, they were found in the bottom of the pipe trench (Pl 9, and for context Pl. 1), probably at around 2.20 m below ground level and appear to have been shallowly founded in (probably natural) gravel (through which water flowed into the trench, suggesting that they were at the level of the water table). [157]/[158] then may have been parts of a structure rising from a (wet) moat immediately to their east and [152] appears likely to have been of the same phase given its agreement of alignment with them. It was two and a half bricks thick at the photographed level (Pl. 7)<sup>19</sup> and Pl. 6 suggests that it leaned slightly to the east by the time a later wall ([153]; the straight joint is unequivocal on Pls 6 - 7), was built up against it on that side.

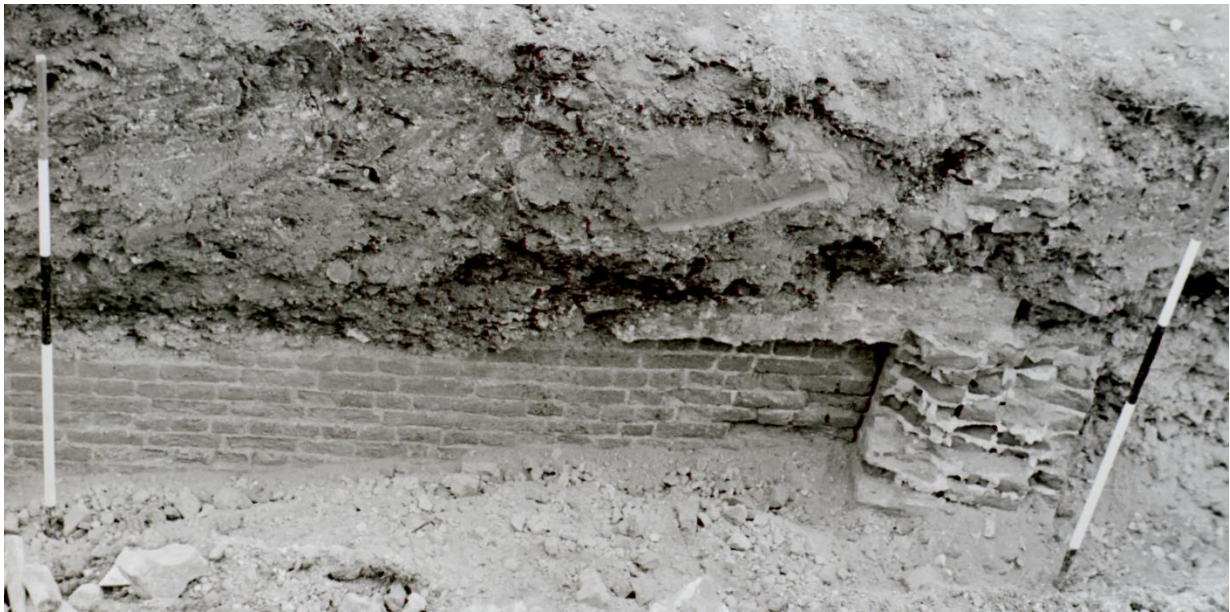
Pl. 7: Wall [153] Running up to Wall [152] (on Right) with Later Wall [153A] Above Both, Looking South

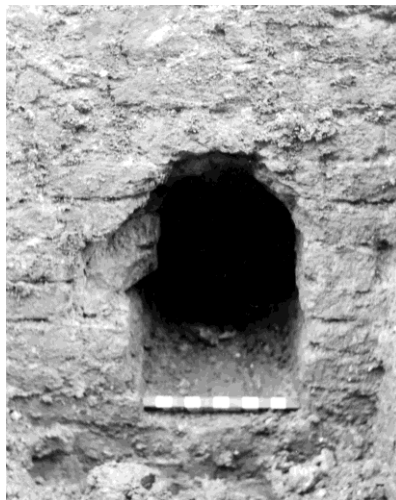
Pl. 8: The Small ‘Drain’ in the North Face of Wall [155], Looking South.

Wall [153] ran east up to a probably integral rectangular structure [154] which projected into the trench from the south. This last was presumably a substantial construction with its northern wall around 1.00 m thick (if what was recorded in plan was the wall not a wider foundation for one), an internal width of over 3.00 m and what might have been a c. 1.20 m long extension, [155], to the east pierced by what Drayton thought at least was a small drain. The ‘drain’ though (Pl. 8) did not continue across the width of the gas main trench, was only 12 inches (0.30 m) wide and 20 inches (0.50 m) high<sup>13</sup> and as it evidently ran south (not north towards Maidens Brook) whether it was a drain at all must be in doubt.

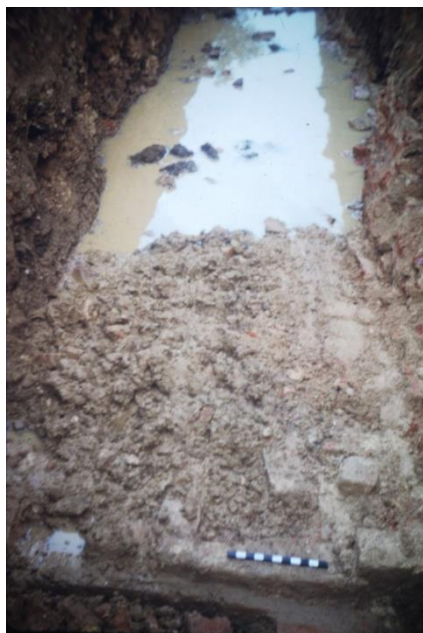
Pl. 9: Walls [158] (With Scale on it) and [157] (Far Right in the Side of the Trench), Looking East.

West of this records are even more sketchy. Two ?walls projecting 1.58 m into the trench from the north and together 1.28 m wide, [156], are only known from the plan (Fig. 2) which shows one forming an L-shape partly round the other (?as if to encase something such as a water pipe). About 1.58 m further east and evidently particularly disrupted/demolished, traces of two more walls, [157] and [158], probably amongst a deposit of brick rubble, seem to have been recorded, but the drawn section in this case is especially ambiguous and photographs (Pls 9 - 10) demonstrate that this area was flooded (see also Pl. 1)

so the walls may have been founded below the level of the water table. Wall [157] appears to have been over 8.53 m in east west extent and [158] may have been about 0.40 m thick.

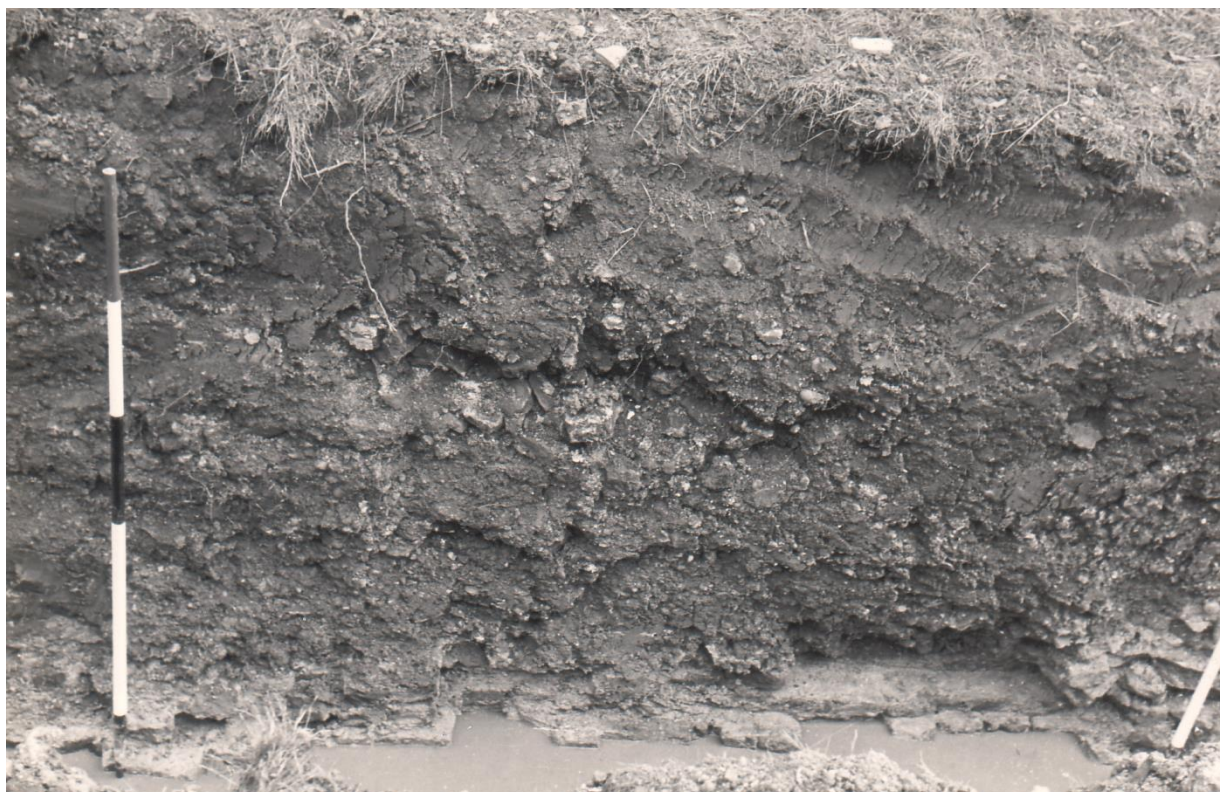
Pl. 10: Wall [157], Looking South

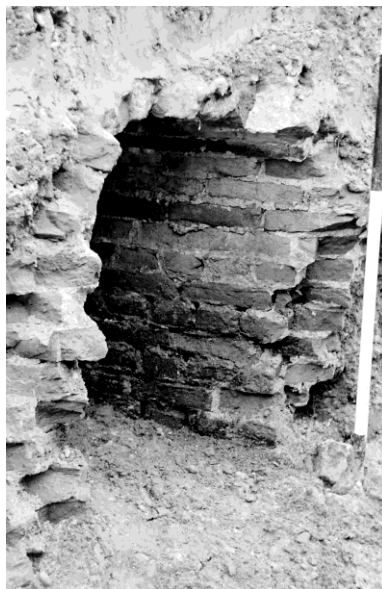
Pl. 11: Drain [159], Presumably Looking South.

What is clearer is that not far east of this a substantial (around 0.60 m wide and 0.85 m high internally) vaulted drain [159] crossed the trench at an angle (Pl. 11).

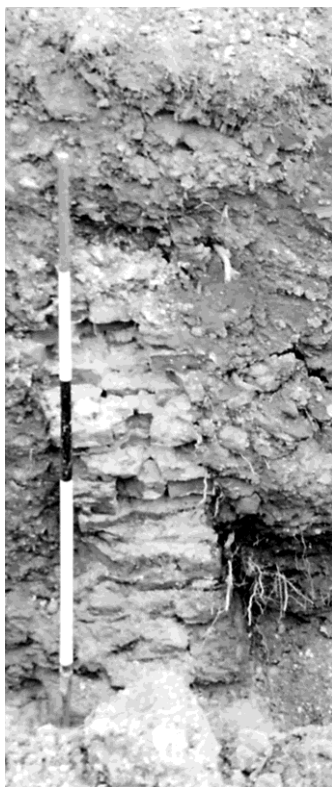
Pl. 12: Wall [160], Presumably Looking South.

Of three other features identified by Drayton in the main area where structures were recorded one, [161], we know nothing about except that it is marked on the plan as of her Phase II, but it cannot have been more than a small fragment of brickwork perhaps suspiciously close to drain [159] to be a separate feature. A second though, [160] (Pl. 12), was a wall, perhaps only around 0.40 m thick and clearly on a quite different alignment to other features recorded. It incorporated a turn marked by an octagonal brick pillar (Pl. 13) ‘with sides 14 inches [0.35 cm] long’,<sup>14</sup> which had been extracted by the contractors and left on the spoil heap.

Significant clues to interpreting what the features in the gas main trench represent seem to lie at the east end of the main recorded section. Here one can see that wall [160] had a battered but regular west face and a very irregular east face, built against a rough cut in the ground and filling its irregularities; the typical form of a retaining wall (Pl. 12). It survived to at least 1.50 m high and the cut seems likely to have been that of the moat enclosing the inner court, [160] presumably rising above ground level as a low balustrade wall. The octagonal shaft or pier, with faces 1.5 bricks/ 0.35 m wide (Pl. 13), marked a change of direction of the edge of the moat and [160] and this finds a ready parallel at Hampton Court in the stone shafts which rise above the crenelated parapet of the outer court bridge, begun in 1535, and which carry heraldic beasts.<sup>17</sup> The parallel implies that in this location the moat wall was prominent in a significant view, whether from within the inner court buildings or (less likely) of them from an approach. Together with the presence of building fragments to the west, it therefore seems that the pipe trench cut a transect across the northern edge of the inner court where a moat had curved out to the north to enclose it in what for convenience might be called Phase A.

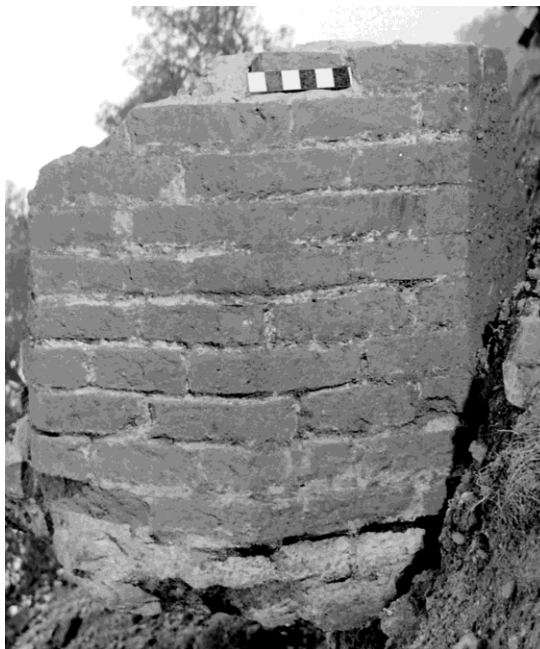
Pl. 13: Octagonal Brick Pillar Contractor Removed from [160].

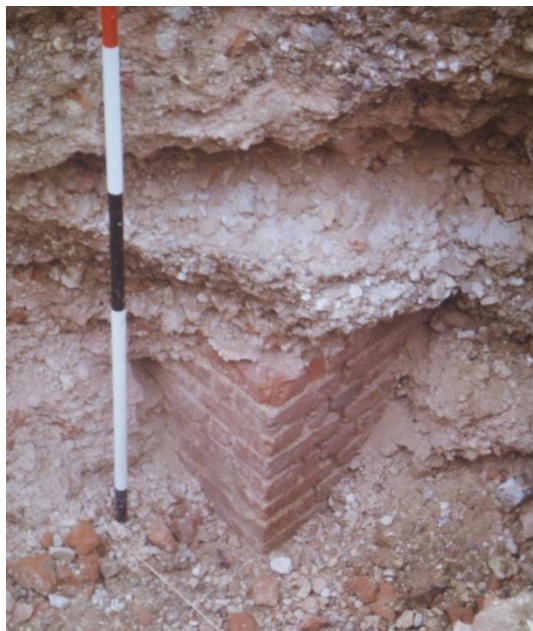
Pl. 14: Wall [162], Looking North.

The final feature, [162], is probably what Drayton commented of that it ‘might well have belonged’ to a structure of her Phase II ‘judging from its general appearance, the type of mortar (much sandier than in Phase III) and the fact that it was completely out of alignment with the other walls’.<sup>15</sup> One photograph (Pl. 14) likely shows it and indicates that it was the corner of a structure.

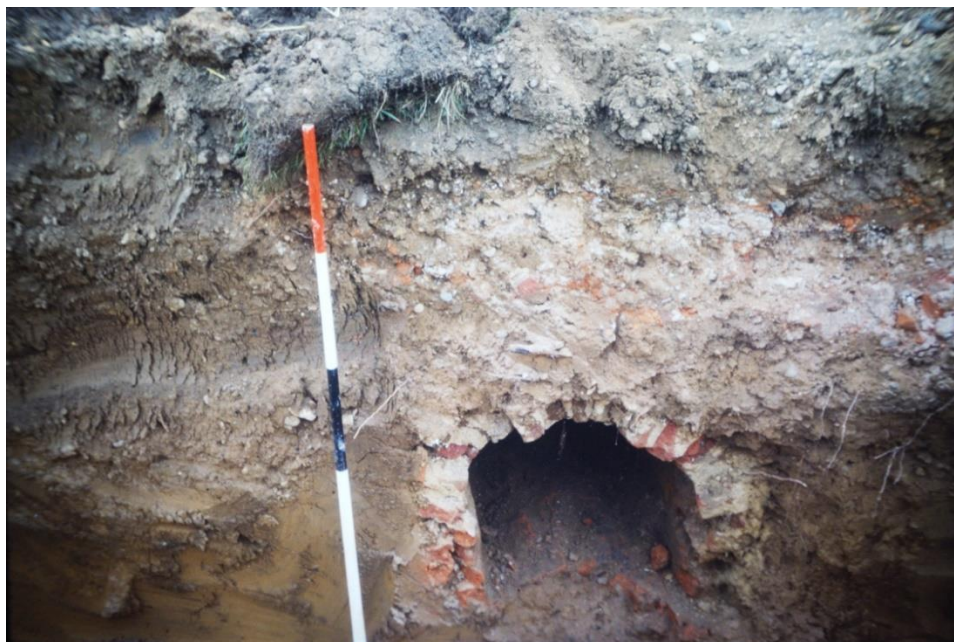
Pl. 15: Drain [165], Presumably Looking South.

feature was another vaulted brick drain, [165], c. 25.30 m west of the 'moat'. It (Pl. 15) is shown with an internal width and height both of somewhere around 0.60 m and lay under a deposit of rubble.
